## STAFF REPORT

To: Capital Improvement Grant Consideration: Atlas Theater  
Location: 211 W. Lincolnway  
Date: May 16, 2024  
Staff Contact: Irene Parsons, DDA Main Street Manager

### **ATLAS THEATER – STRUCTURAL CONDITION ASSESSMENT**

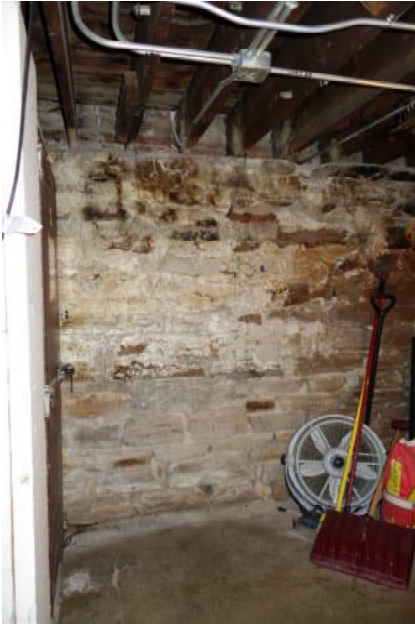
Photo 1 – General condition of stacked stone foundation wall. Efflorescence is visible in the top left corner of the wall.

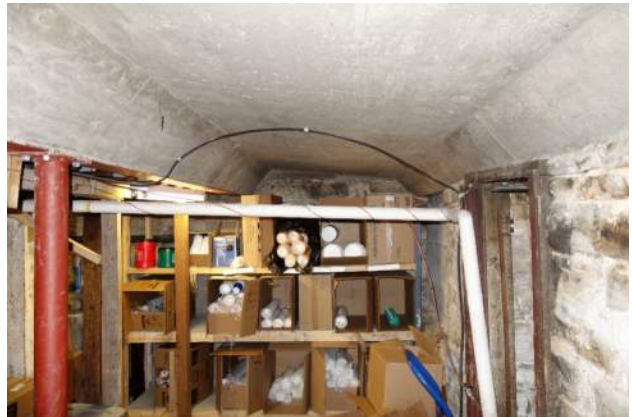
Photo 2 – Concrete roof over basement on north end of building. This is also the sidewalk beneath the building's overhang.

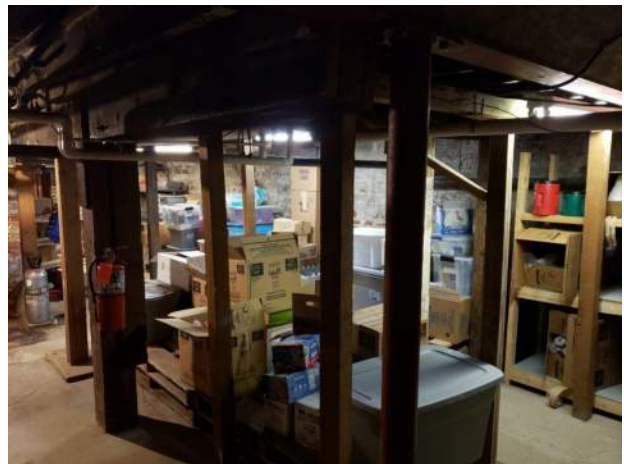
Photo 4 – Main floor framing (visible from basement) which has been supported by randomly placed posts.

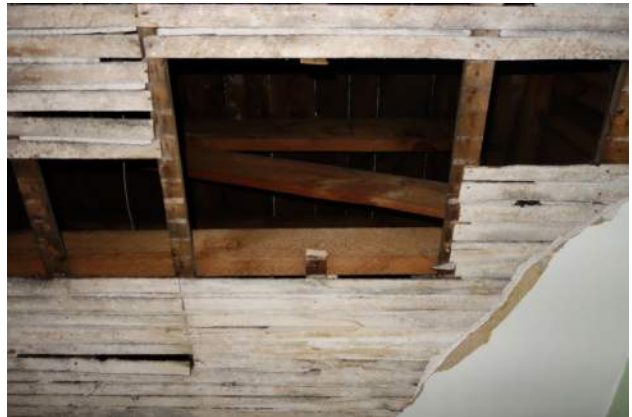
Photo 6 – Site built wood trusses (visible through a damaged area in the ceiling).

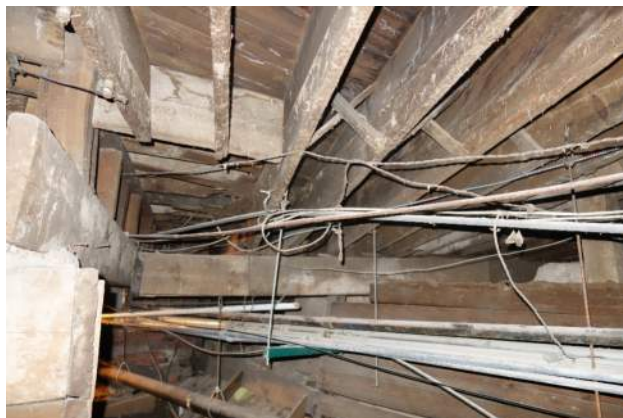
Photo 7 – Foundation and floor framing below the Auditorium.

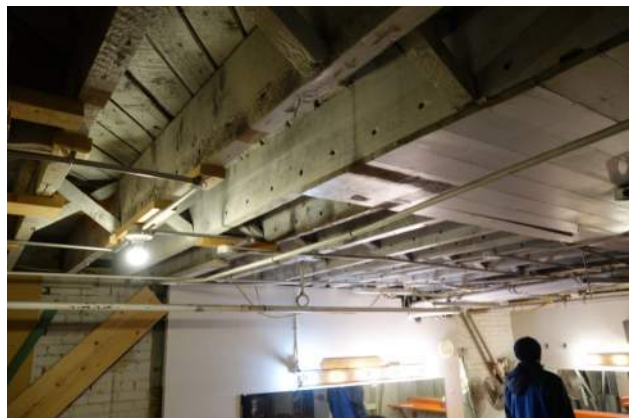
Photo 8 – Floor joists supporting the Stage area. Floor joists have been drilled on a regular pattern.

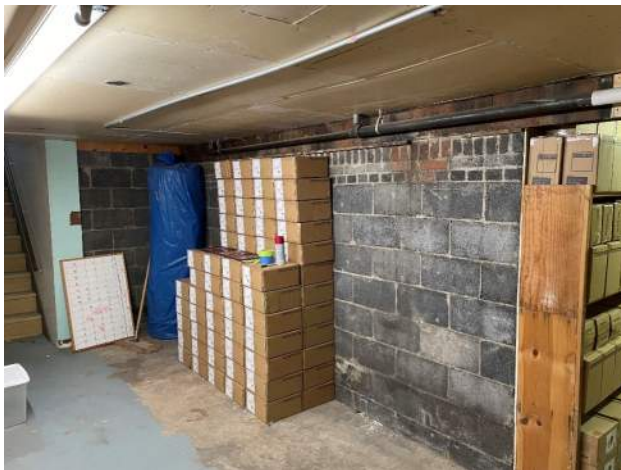
Photo 11 – CMU foundation wall visible from basement of 215 W. Lincolnway.

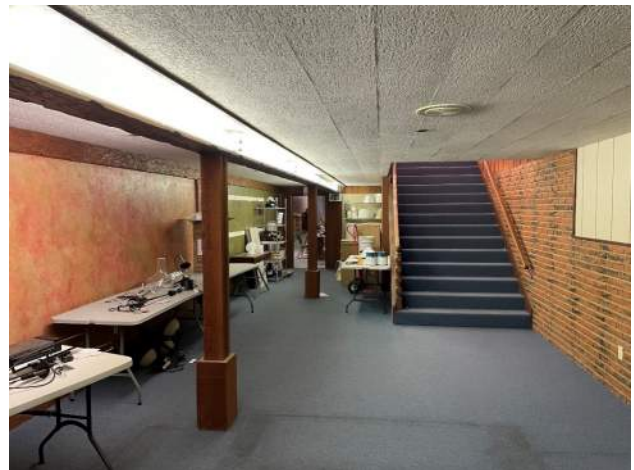
Photo 12 – Wrapped steel beam supported by posts in basement of 215 W. Lincolnway.

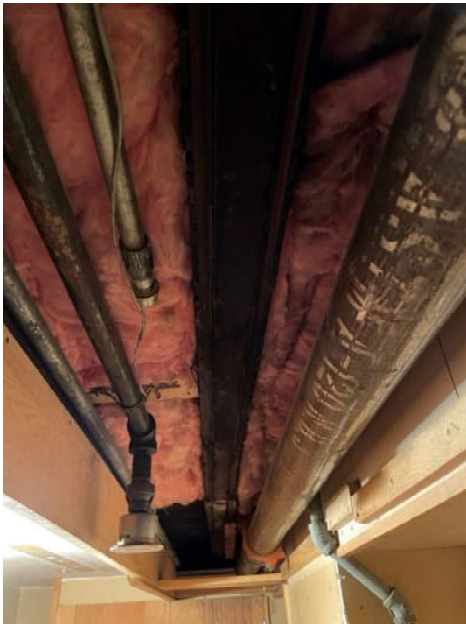
**Photo 13** – Fire damage to the main floor joist as seen from the north end of the basement at 215 W. Lincolnway.

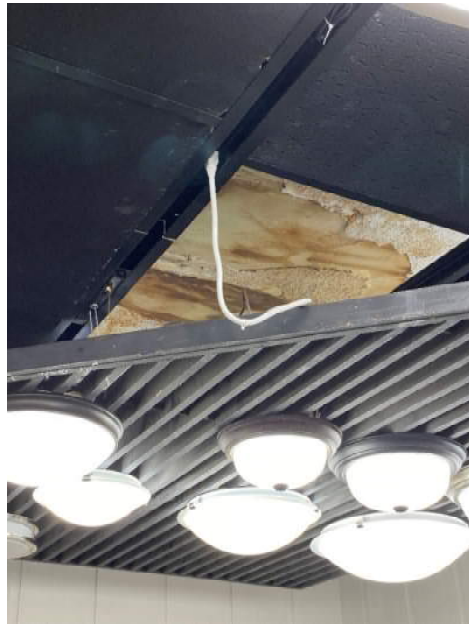
**Photo 14** – Water damage to the main floor ceiling at 215 W. Lincolnway.

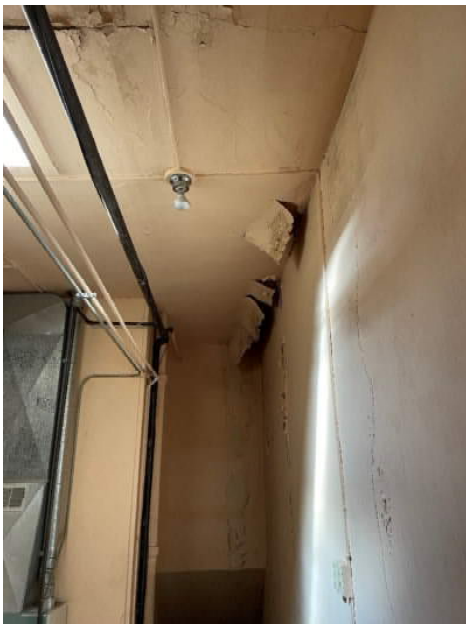
**Photo 15** – Water damage to the second-floor ceiling (above the stair) at 215 W. Lincolnway.

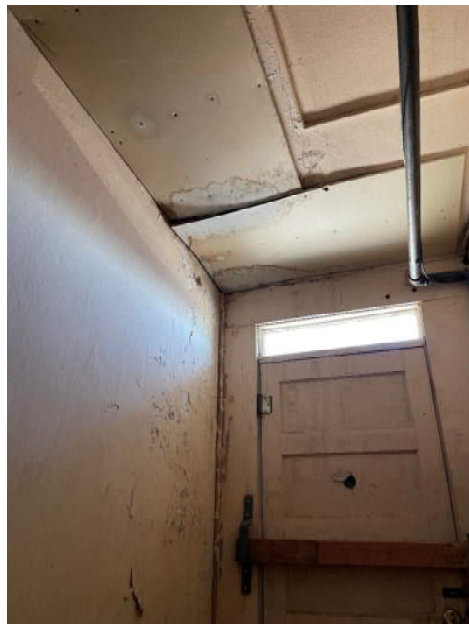
**Photo 16** – Water damage to the second-floor ceiling (above the south door to the low roof) at 215 W. Lincolnway.

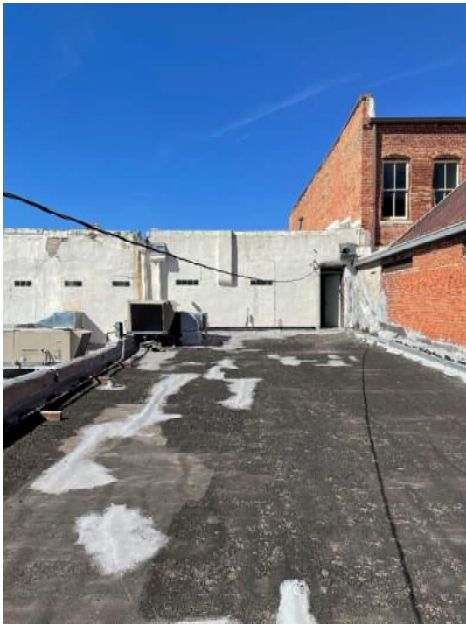
**Photo 17** – Parapet walls extending above roof of 215 W. Lincolnway.

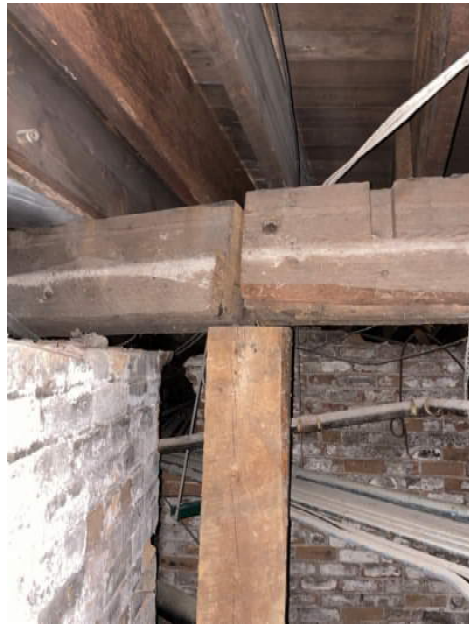
**Photo 18** – Auditorium floor framing. Girders do not have solid bearing on post.

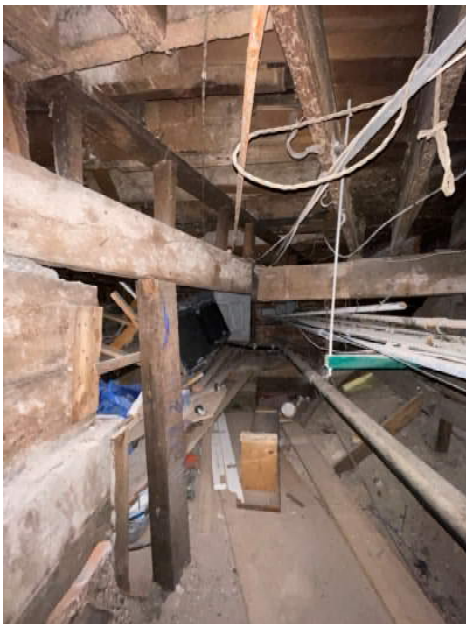
**Photo 19** – Poor workmanship framing modifications under the Auditorium floor.

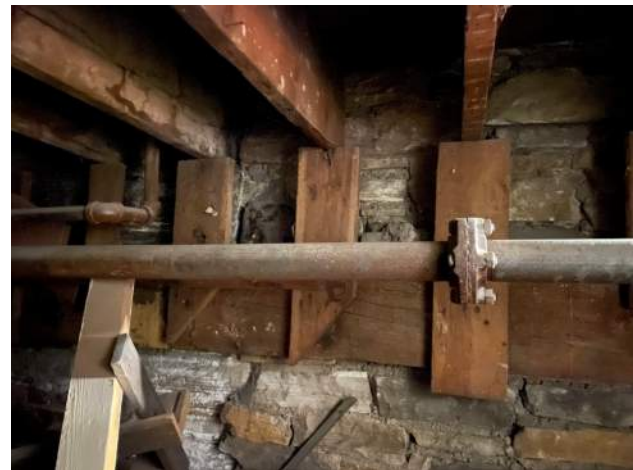
**Photo 20** – Poor workmanship framing modifications under the Auditorium floor.

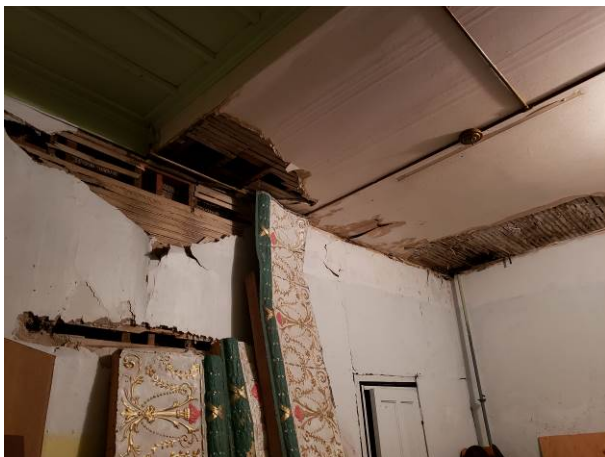
**Water damage to plaster detail**

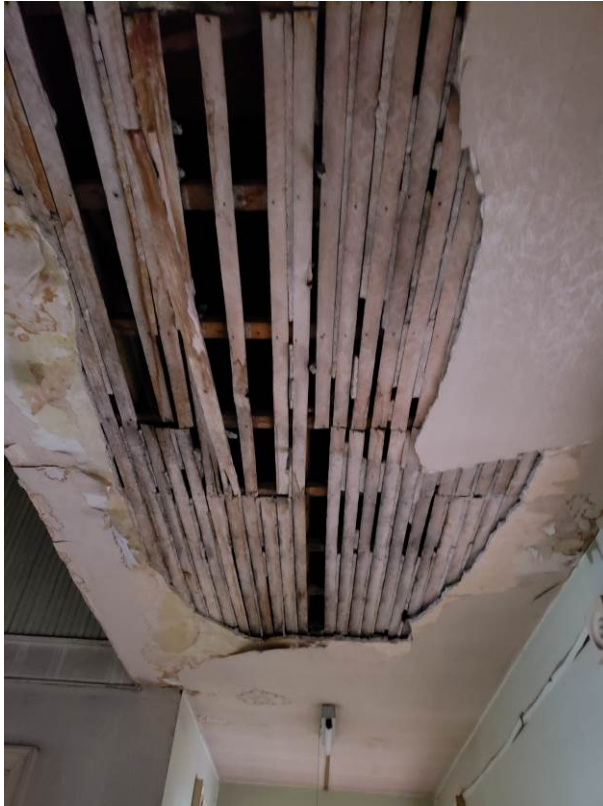
**Ceiling plaster water damage**

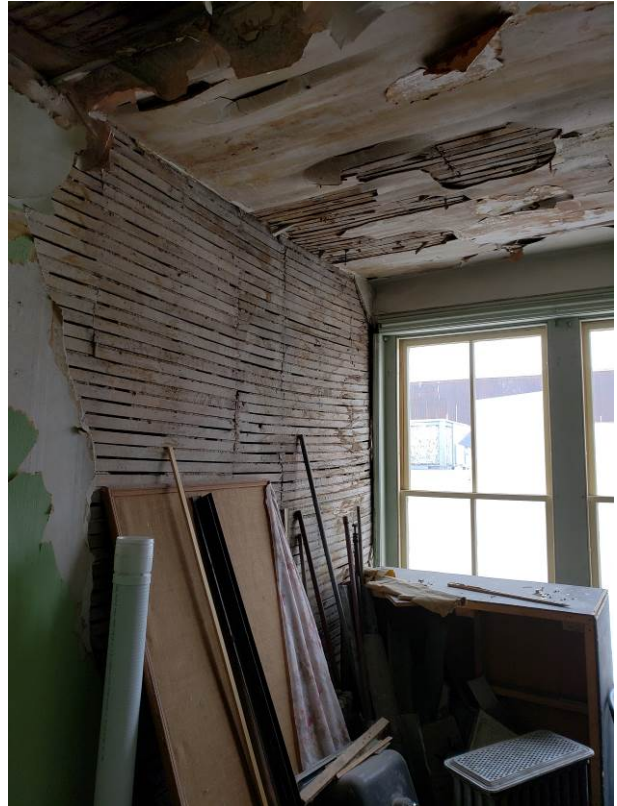
**Ceiling and wall plaster water damage at rooms on South side**
