# Conditions of Blight - Ridge and Holland

## City of Cheyenne

Exhibit A: Produced to support Resolution Determining Blight

Produced September 2023  
Planning and Development Department  
Lonnie Olson, Planner I

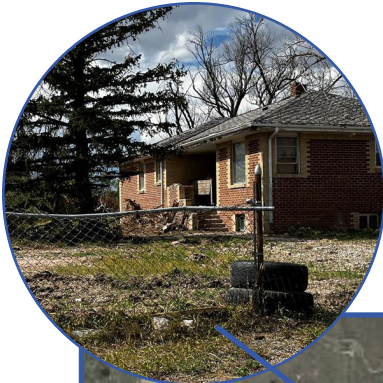
1. Deteriorated or Deteriorating Structures

The Ridge and Holland study area contains several examples of deteriorated or deteriorating structures. The residence on the large parcel contained within the study area is in very poor shape as the roof is deteriorating and the façade has joints cracking and failing and thus the bricks have started separating away from each other creating unsafe conditions. The main residence also has many broken windows. Many of the sheds on the large parcel, that the residence is next to, are in poor shape and show signs of a lack of upkeep. Some of the structures are utilizing tires to hold down the roof and show signs of significant deterioration.

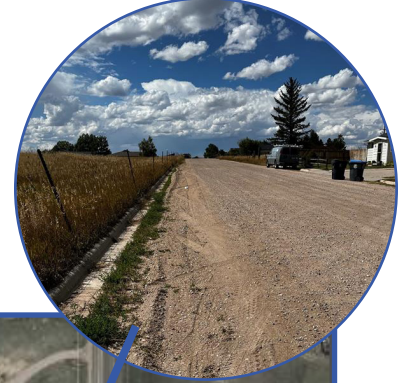
3. Deterioration of Site or Other Improvements

The Ridge and Holland study area has deteriorated or missing street, curb, gutter, and sidewalk in various locations. The deteriorated site conditions have exacerbated the substandard pedestrian connections in the study area. The locations that lack curb, gutter, and sidewalk create potential pedestrian and vehicular conflicts. Holland Court in the study area is a dirt road within the City and although it has gutter, it is substandard and fails to meet City standards for roadways. Due to the deteriorated and missing curb, gutter, and sidewalk, and dirt road, staff is satisfied this condition of blight is met.

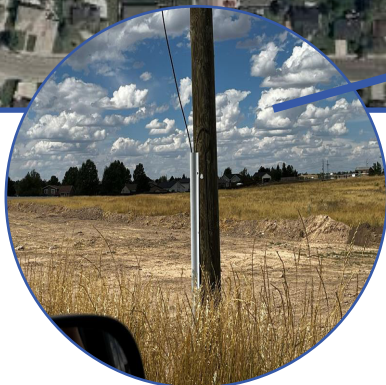
2. Unsanitary or Unsafe Conditions

Staff noted the Ridge and Holland study area lacked pedestrian connectivity primarily on Ridge Road and Holland Court. The lack of safe pedestrian connections poses threats to residents of the neighborhood who would be walking through to go to the nearby park and school. The site also has poor sewerability (ability to provide gravity sanitary sewers) due to previous developments not placing them appropriately to serve multiple parcels in the area. This poses a significant risk to the health of the area as any new development would not
