#### ADDENDUM NUMBER ONE BID S-7-22

Subject: Addendum Number One to Bid S-7-22 for the Landfill & Street and Alley

**Department - Tent Building Repairs**

# CITY OF CHEYENNE, WYOMING TENT BUILDINGS REPAIR

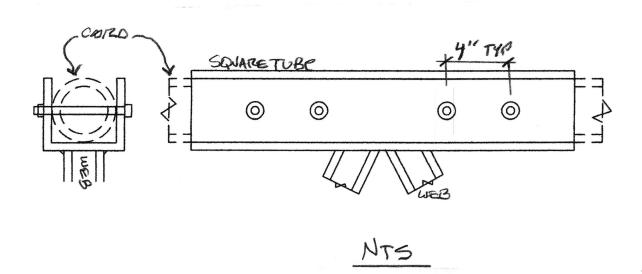
1R.1 REPAIR OF THE END WALL TRUSSES
REPAIR OF THE INTERIOR TRUSSES
SECURE WEST END WALL VERTICAL COLUMNS TO TRUSS CORD
COLUMNS TO TRUSS BOTTOM CORD

**1D.1.** Where truss cord (top and/or bottom) is damaged, cord O.D. =W. And where the truss web brace is disconnected:

Install 3/8" square tube (customized to remove one side); length = 24"; I.D. = W. Connect with (4) 5/8" 120 ksi bolts horizontally.

Replace the damaged truss web legs with 2-1/2", 3/8" square steel tube. Weld the steel web to the steel cord.

**1D.2**. Where truss cord (top and/or bottom) is damaged, cord O.D. =W. And where the end support purlin is disconnected:

Install 3/8" square tube (customized to remove one side); length = 24"; I.D. = W. Connect with (4) 5/8" bolts horizontally.

Reconnect the purlin with two 5/8" 120 ksi bolts attached to a 3/8"x4"x12" steel plate welded to the steel square tube and supported with 4 gussets.

Install 3/8" square tube (customized to remove one side); length = 24"; I.D. = W. Connect with (4) 5/8" 120 ksi bolts horizontally.

Extend the column to the bottom of the steel square tube with a 3/8" square steel tube. Weld the steel extension to the steel square tube. Bolt the steel extension to the existing vertical column with (3) 5/8" 120 ksi bolts horizontally. Make that stated connection on all of the columns on the west wall of building 1.

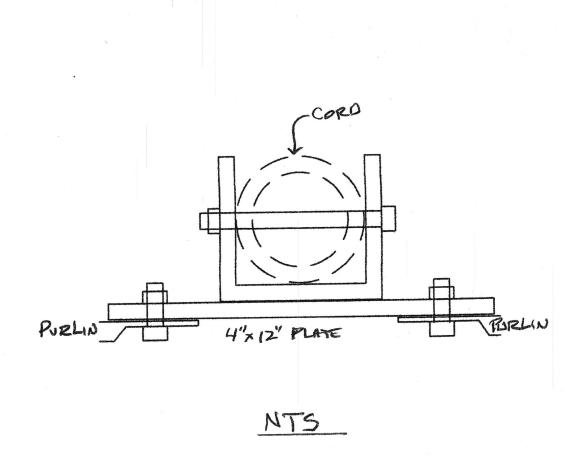
#### 1R.2 REPAIR OF THE INTERIOR TRUSSES

**1E.1.** Where truss cord (top and/or bottom) is damaged, cord O.D. =W. And where the truss web brace is disconnected:

Install 3/8" square tube (customized to remove one side); length = 24"; I.D. = W. Connect with (4) 5/8" 120 ksi bolts horizontally.

Replace the damaged truss web legs with 2-1/2", 3/8" square steel tube. Weld the steel web to the steel cord.

**1E.2.** Where truss cord (top and/or bottom) is damaged, cord O.D. =W. And where the end support purlin is disconnected:

Install 3/8" square tube (customized to remove one side); length = 24"; I.D. = W. Connect with (4) 5/8" bolts horizontally.

Reconnect the purlin with two 5/8" 120 ksi bolts attached to a 3/8"x4"x12" steel plate welded to the steel square tube and supported with 4 gussets.

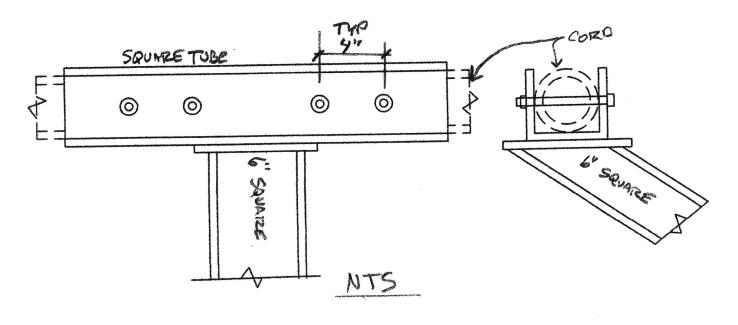
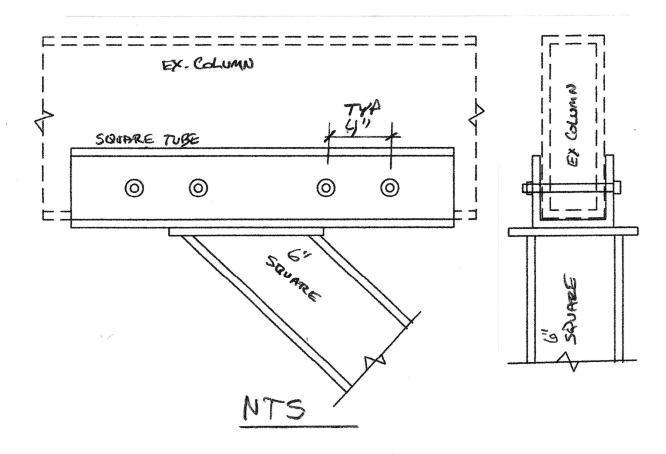
## 1R.3 INSTALL DIAGONAL SUPPORTS FROM WEST END WALL VERTICAL COLUMNS TO TRUSS BOTTOM CORD AT 45 DEGREE ANGLE

Install 3/8"x6" steel square tubing from the bottom cord of the first interior truss to the columns of the west side of building 1 at a 45 degree angle. Install the diagonal support on all of the columns on the west wall except the (2) end columns.
