# Conditions of Blight - Jolly Rogers and Expanded Downtown City of Cheyenne

Exhibit A: Produced to support Resolution Determining Blight

Produced Spring 2023  
Planning and Development Department  
Lonnie Olson, Planner I

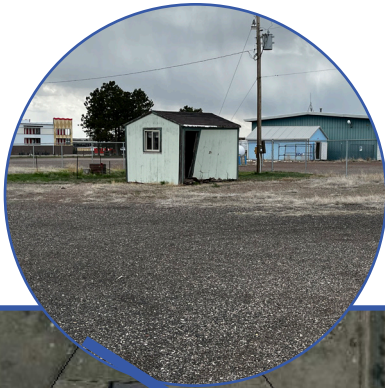
1. Deteriorated or Deteriorating Structures

The Jolly Rogers study area contains several examples of deteriorated or deteriorating structures. Two of the buildings on the Jolly Rogers property are in poor condition with one of them missing portions of one wall. In addition to the building missing a wall, other buildings in the area show evidence of deterioration. The prevalence of deteriorating buildings as depicted in the supporting photographs fulfills this condition of blight.

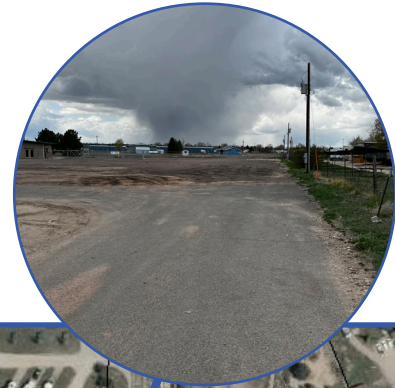
2. Predominance of Defective or Inadequate Street Layout

The Jolly Rogers property is approximately 12 acres with only two accesses that is off a major highway and the other could cause traffic conflicts with its proximity to the highway. The lot lacks circulation with the adjacent neighborhoods and has no safe pedestrian connectivity. The street network through the area is not sufficient for urban development and connections will need to be planned and built-in accordance with the reconstruction of U.S. Highway 30. Due to the faulty street network through the Jolly Rogers, the lack of adequate access, and how one of the two accesses to the site have the potential to create traffic conflicts, staff is satisfied this condition of blight is met.

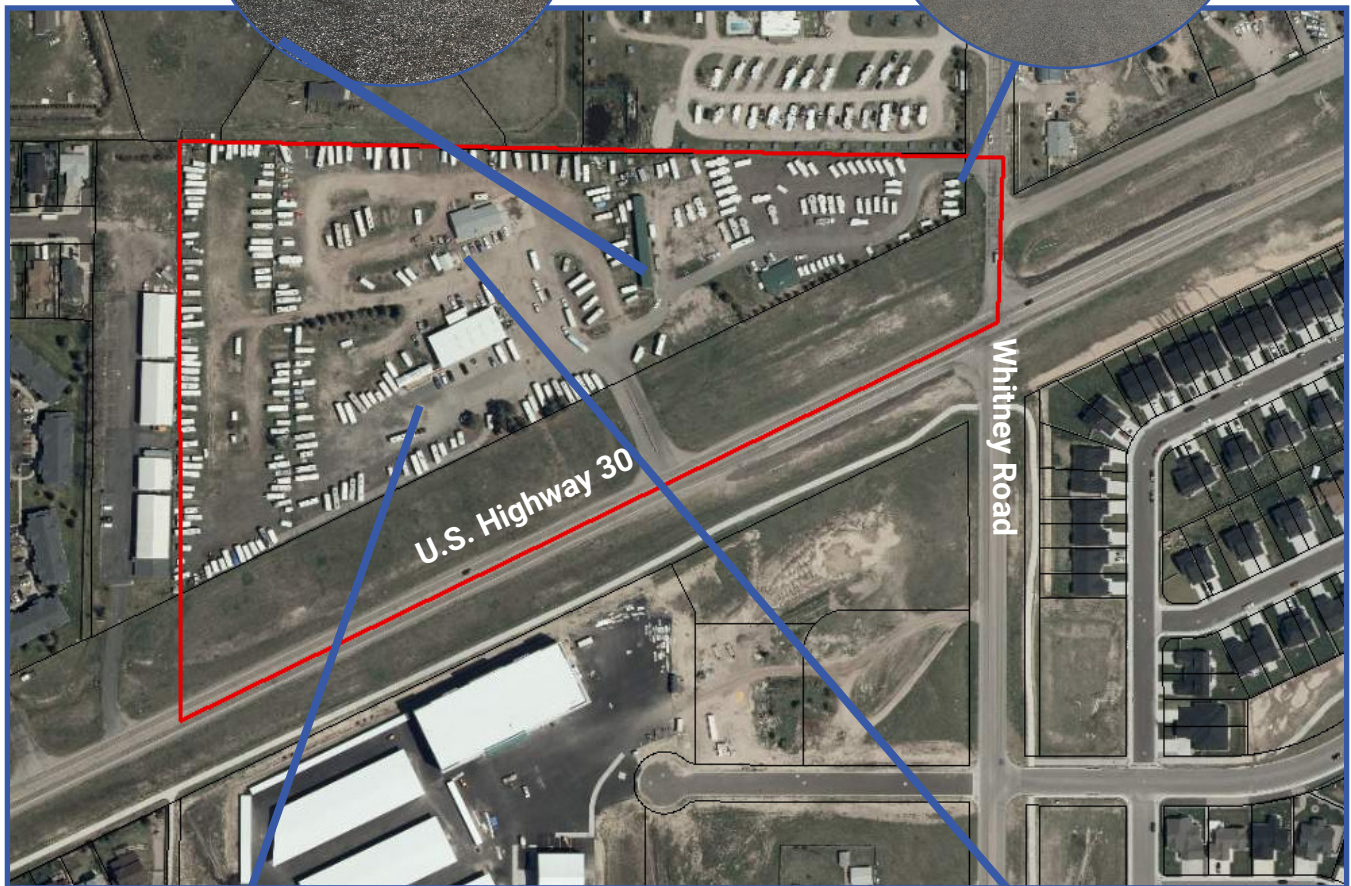
# Figure 1: Jolly Rogers Study Area

The Jolly Rogers study area is shown in Figure 1. The study area includes the Jolly Rogers Subdivision on the northwest corner of the intersection of U.S. Highway 30 and Whitney Road. The site contained four (4) of the nine (9) conditions of blight identified on the survey, demonstrating an area of blight in the community.

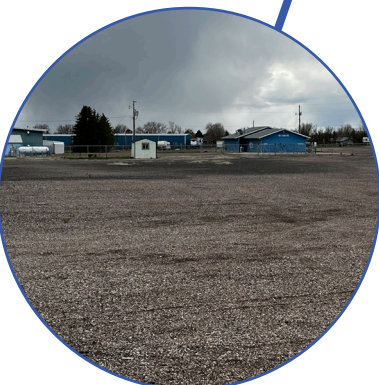
3. Faulty Lot Layout in Relation to Size, Accessibility, or Usefulness

The Jolly Rogers property is large lot with only two accesses with one off a major highway and the other could cause traffic conflicts with its proximity to the highway. The lot is an abnormal shape with one street frontage only having approximately ~100 feet of frontage where the other street frontage has over 1,000 feet. The size and shape of the block combined with their limited lack of quality access connections yield a faulty lot layout in relation to size, accessibility, and usefulness; thus, meeting this condition of blight.

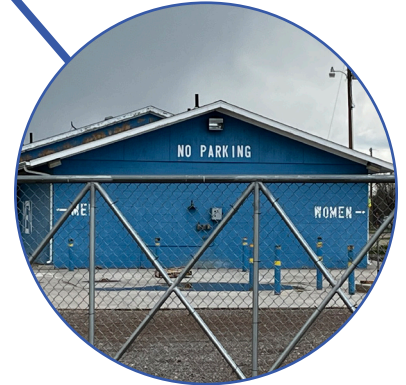
4. Unsanitary or Unsafe Conditions

Staff noted the Jolly Rogers study area lacked pedestrian connectivity. The lack of internal connections through the site lead to accessibility issues and a lack of pedestrian connections. The lack of pedestrian connectivity along a major Highway has the potential to create unsafe conditions for those who use alternative modes of transportation. The site was home to an RV service area which could have some potential environmental contamination from the service area and if the site was used as a waste dump. The lack of pedestrian access and potential of environmental contamination yields unsafe conditions, thus, meeting this condition of blight.

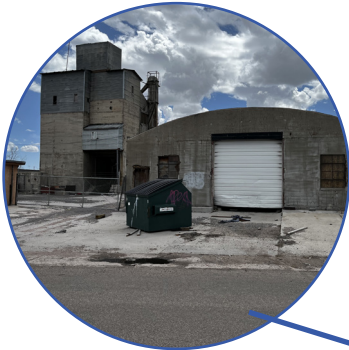
1. Deteriorated or Deteriorating Structures

Staff noted several deteriorating buildings in the Expanded Downtown area. Examples include 819 E 15th Street and 607 E Lincolnway; though several other buildings appear to be deteriorating and may be more so on the interior. Indicators of deterioration witnessed include evidence of fire, boarded up buildings, and faulty building siding. The adjacent photos and those in Appendix B illustrate the study area meets this condition of blight.

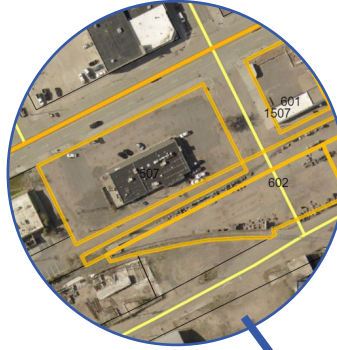
2. Predominance of Defective or Inadequate Street Layout

The eastern portion of the Expanded Downtown study area contains large lots with few street connections. Staff noted that between House Avenue and Morrie Avenue and 15th Street and Lincolnway had poor connectivity in relation to the surrounding areas. Due to the faulty street network and the lack of adequate access, staff is satisfied this condition of blight is met.

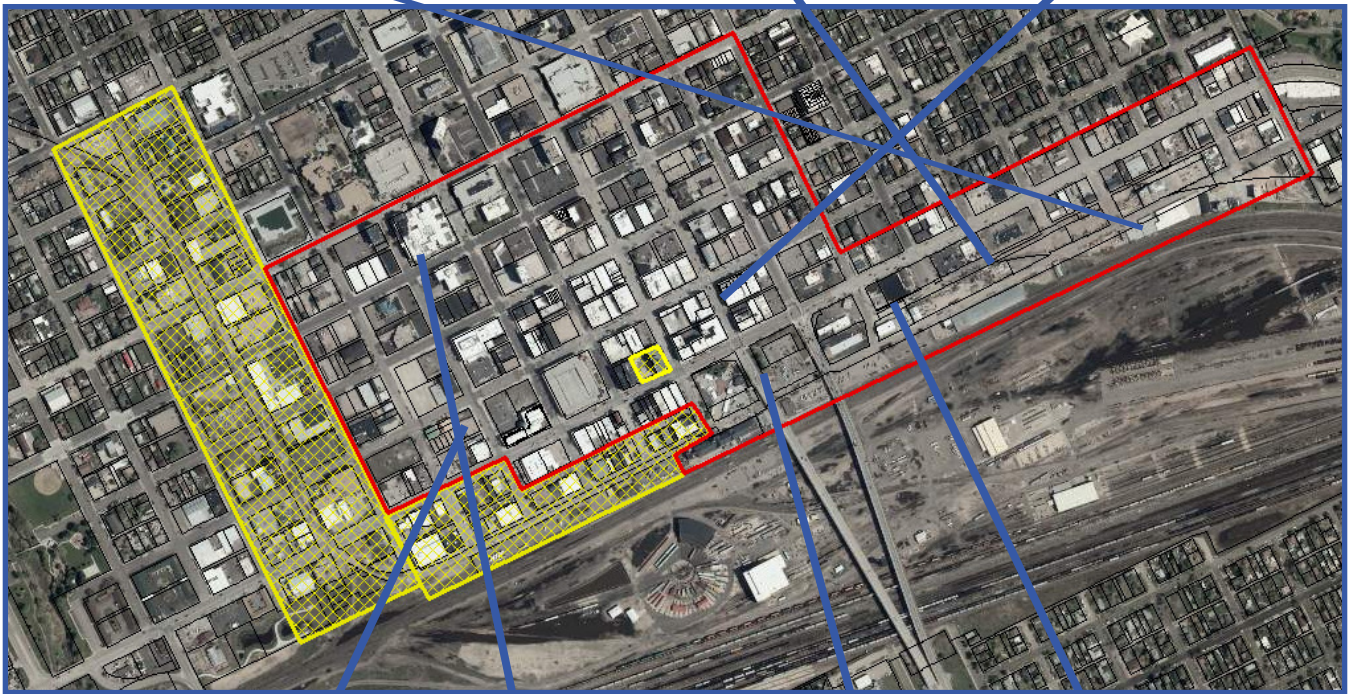
## Figure 2: Expanded Downtown Study Area

The Expanded Downtown study area is shown in Figure 2. The study area includes the blocks between Bent Avenue and House Avenue from the east to west and between 20th Street and the Union Pacific Railroad from the north to south, continuing along from House Avenue to Morrie Avenue from the east to the west and between the alley of 17th and Lincolnway to the Union Pacific Railroad from the north to the south. The study area included seven (7) of the nine (9) conditions of blight identified in the survey, demonstrating an area of blight in the community.

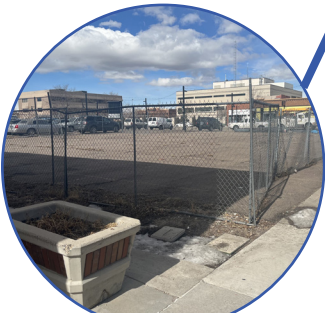
4. Unsanitary or Unsafe Conditions

The Expanded Downtown area contained litter and a lack of connections between Lincolnway and East 15th street, meeting unsanitary conditions and unsafe conditions. Furthermore, the prevalence of industrial businesses and the age of the buildings in the area allude to possible environmental contamination. The litter, lack of connections, and environmental contamination confirm the presence of unsanitary and unsafe conditions throughout the Expanded Downtown study area.

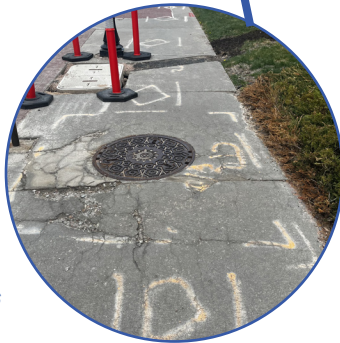
5. Deterioration of Site or Other Improvements

The Expanded Downtown study area has deteriorated or missing curb, gutter, and sidewalk in various locations. The deteriorated site conditions have exacerbated the pedestrian connections in the Expanded Downtown. The locations that lack curb, gutter, and sidewalk create potential pedestrian and vehicular conflicts. Due to the deteriorated and missing curb, gutter, and sidewalk, staff is satisfied this condition of blight is met.

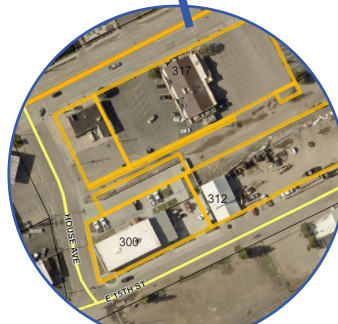
6. Diversity of Ownership, Tax or Other Special Assessments

The Expanded Downtown study area contains a wide variety of ownership, making planning holistically difficult. A wide variety of ownership fosters many different perspectives and needs to be met. The corridor contains both public and private ownership, as well. It is also noteworthy that there are several owners that reside out of state. Staff noted that lots have been divided and sold through informal subdivision processes and that has created issues with ownership of parcels of land. Due to the variety of ownership and informal subdivision process, staff is satisfied this condition of blight is met.

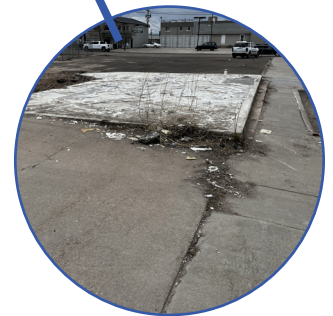
6. The Existence of Conditions which Endanger Life or Property by Fire and other causes

The parcel located at 701 E Lincolnway burned in a fire in 2022 and remains a vacant lot. The potential environmental contamination from previous uses and the age of the structures lead to the probable contamination in the study area yield another condition that may endanger life and property. The noted fire and environmental contamination fulfill this condition of blight.
