## STAFF REPORT

To: Capital Improvement Grant Consideration: Atlas Theater  
Location: 211 W. Lincolnway  
Date: May 16, 2024  
Staff Contact: Irene Parsons, DDA Main Street Manager

### **ATLAS THEATER – STRUCTURAL CONDITION ASSESSMENT**

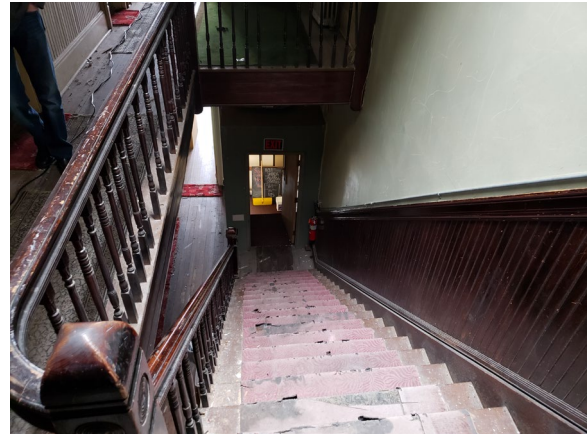
Per Section 805.9, Handrails on just one side of the stair is allowable because the total occupant load served does not require a 66-inch-wide stair. *Will require the installation of a handrail on one side of the grand stair (see photo below).*

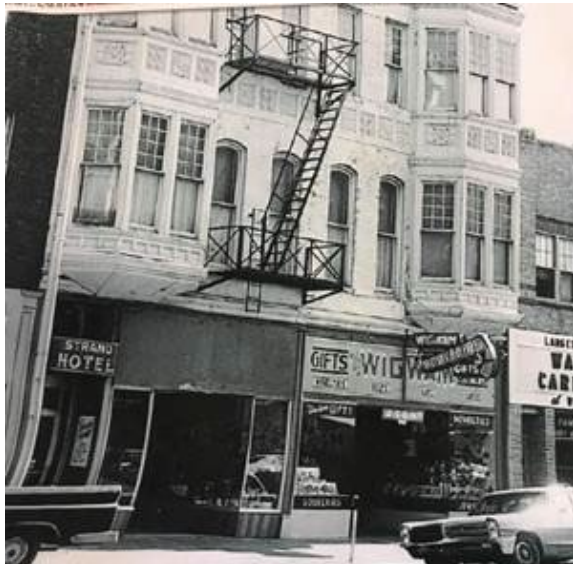
Per Section 805.2, unless there is a distinct hazard, the means of egress complying with the requirements of the building code under which the building was constructed shall be considered to be compliant means of egress (in the opinion of the code official). *The original fire escape have been removed from the office building (was previously located on the main street-fronting façade – see the photo below). Per the City of Cheyenne Building Dept. - the third floor (which previously had a fire escape) must have a second egress (besides the existing stair).*

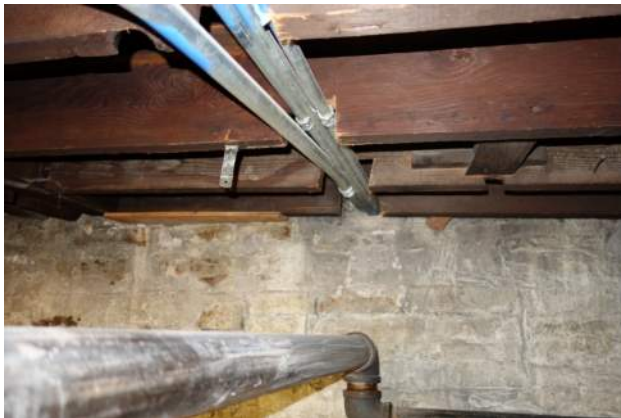
- The floor joists supporting the main floor Lobby area have experienced considerable damage throughout the years. Many of the joists have been cut to simplify the installation of retro-fit plumbing and electrical. See Photo 3 for an example.

Photo 3 – Main floor joists (visible from the basement) were cut to simplify installation of electrical conduit.

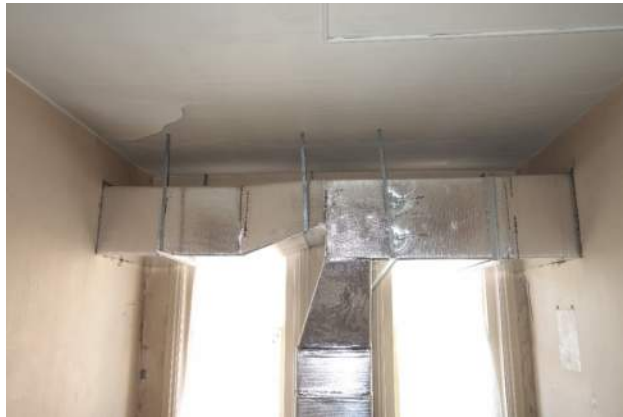
- The interior walls running in the north/south direction on the second and third floors are assumed to be bearing walls. Large openings have been cut into these walls to allow mechanical ductwork to pass through. See Photo 5.

Photo 5 – Third floor bearing walls have been cut to allow passage of mechanical ductwork.

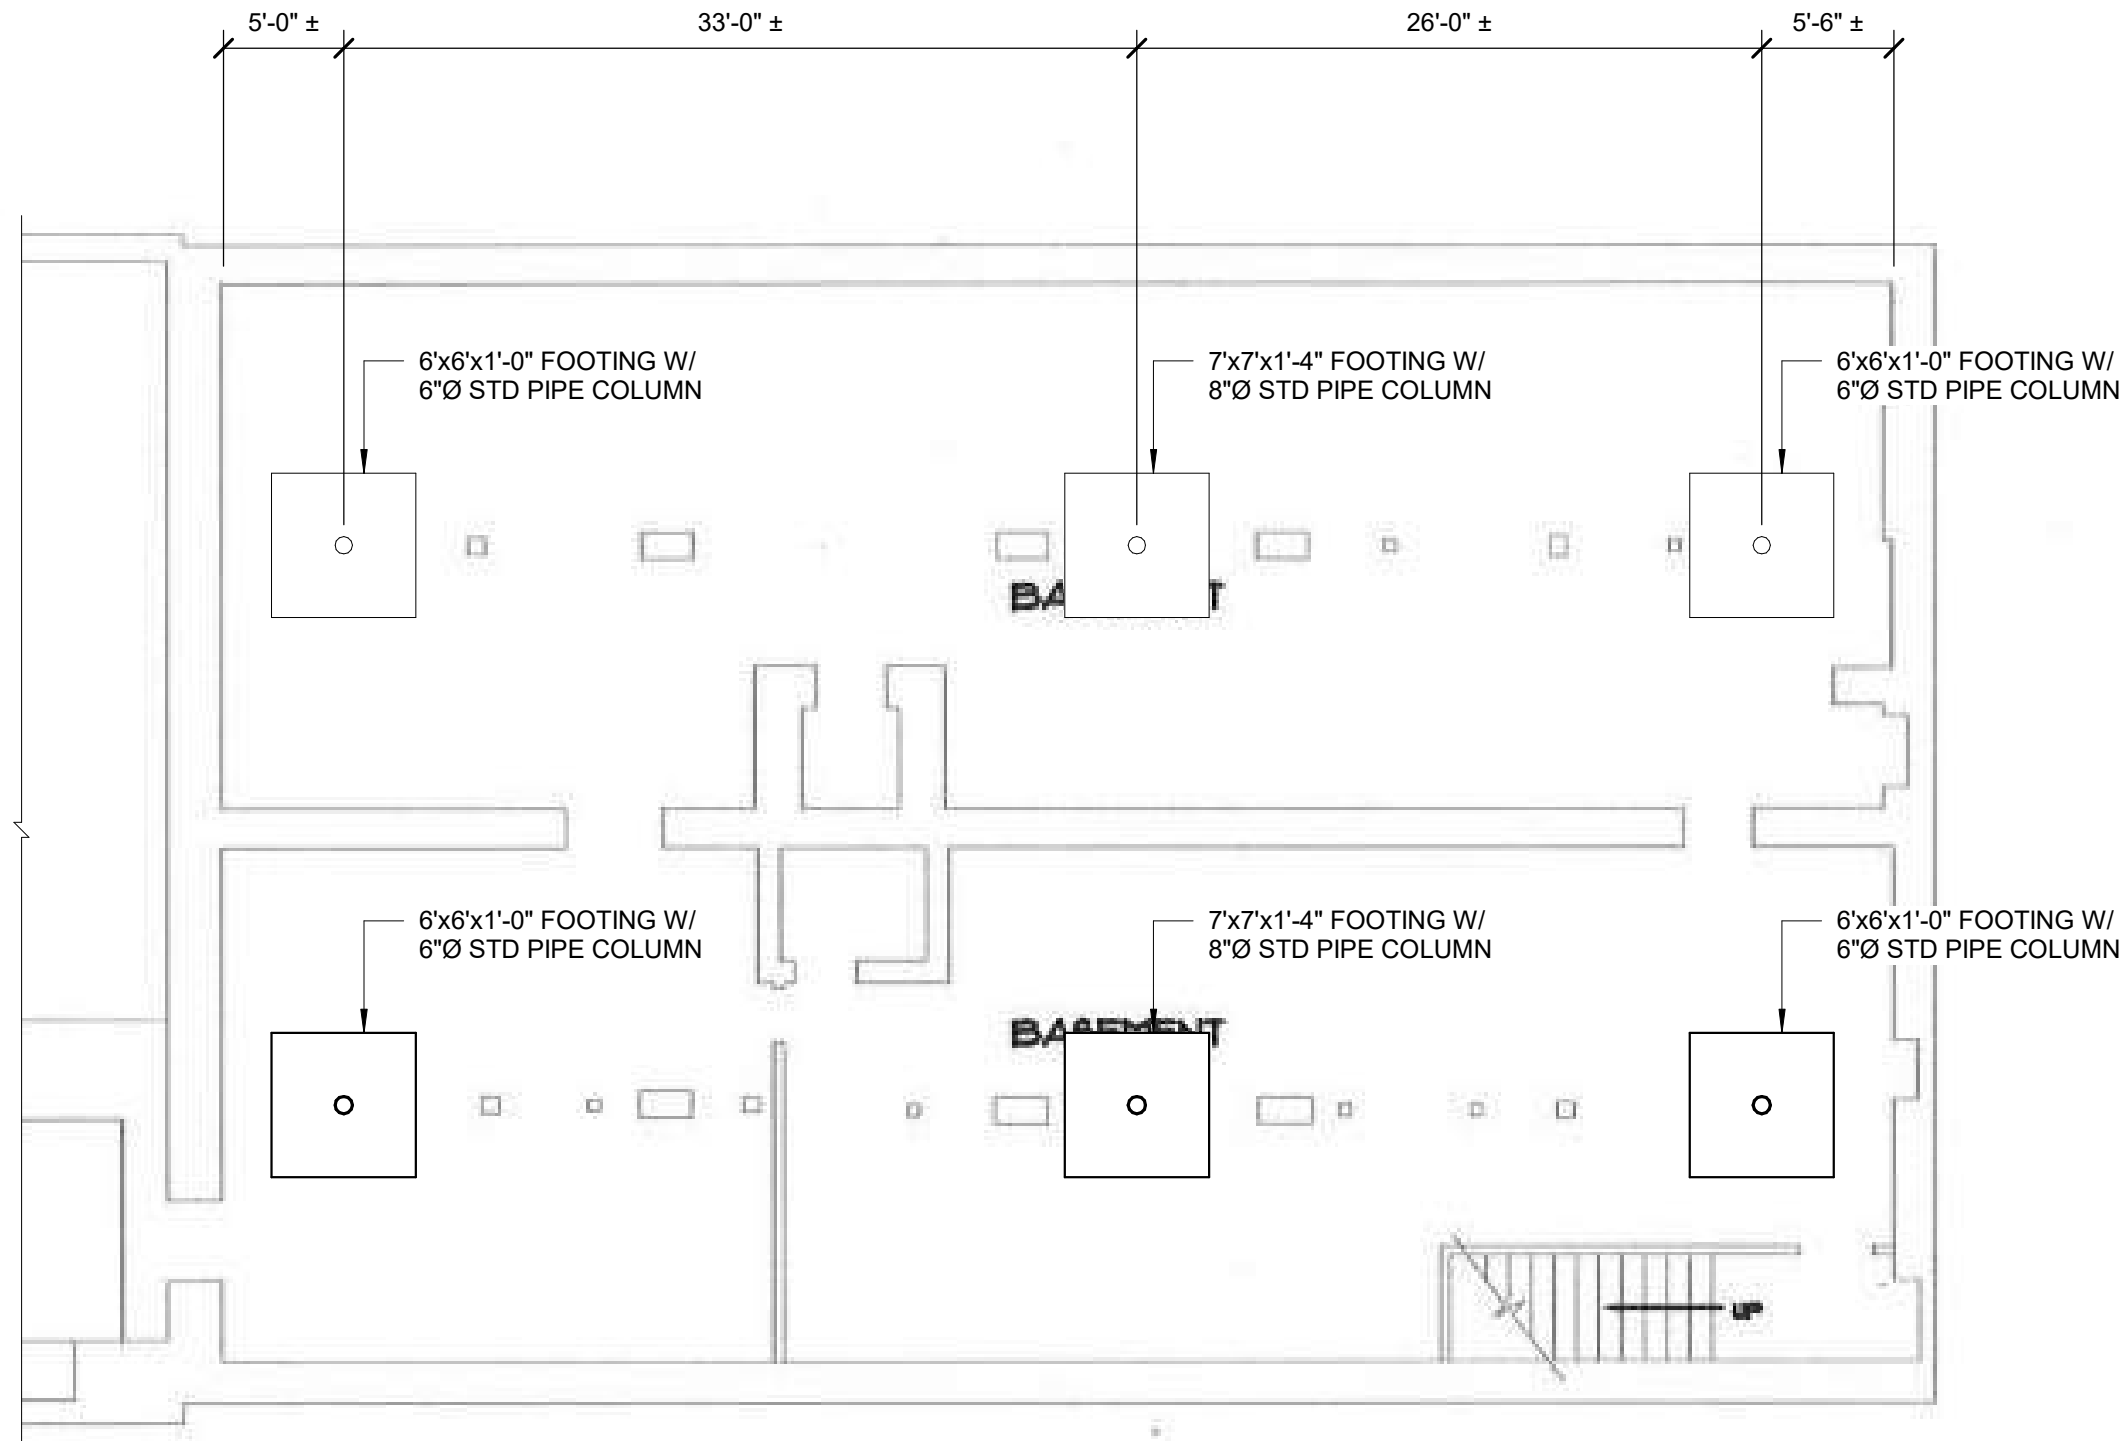
**SK-1**

① **BASEMENT FOUNDATIONS FOR SECOND FLOOR SUPPORT**  
**NO SCALE**

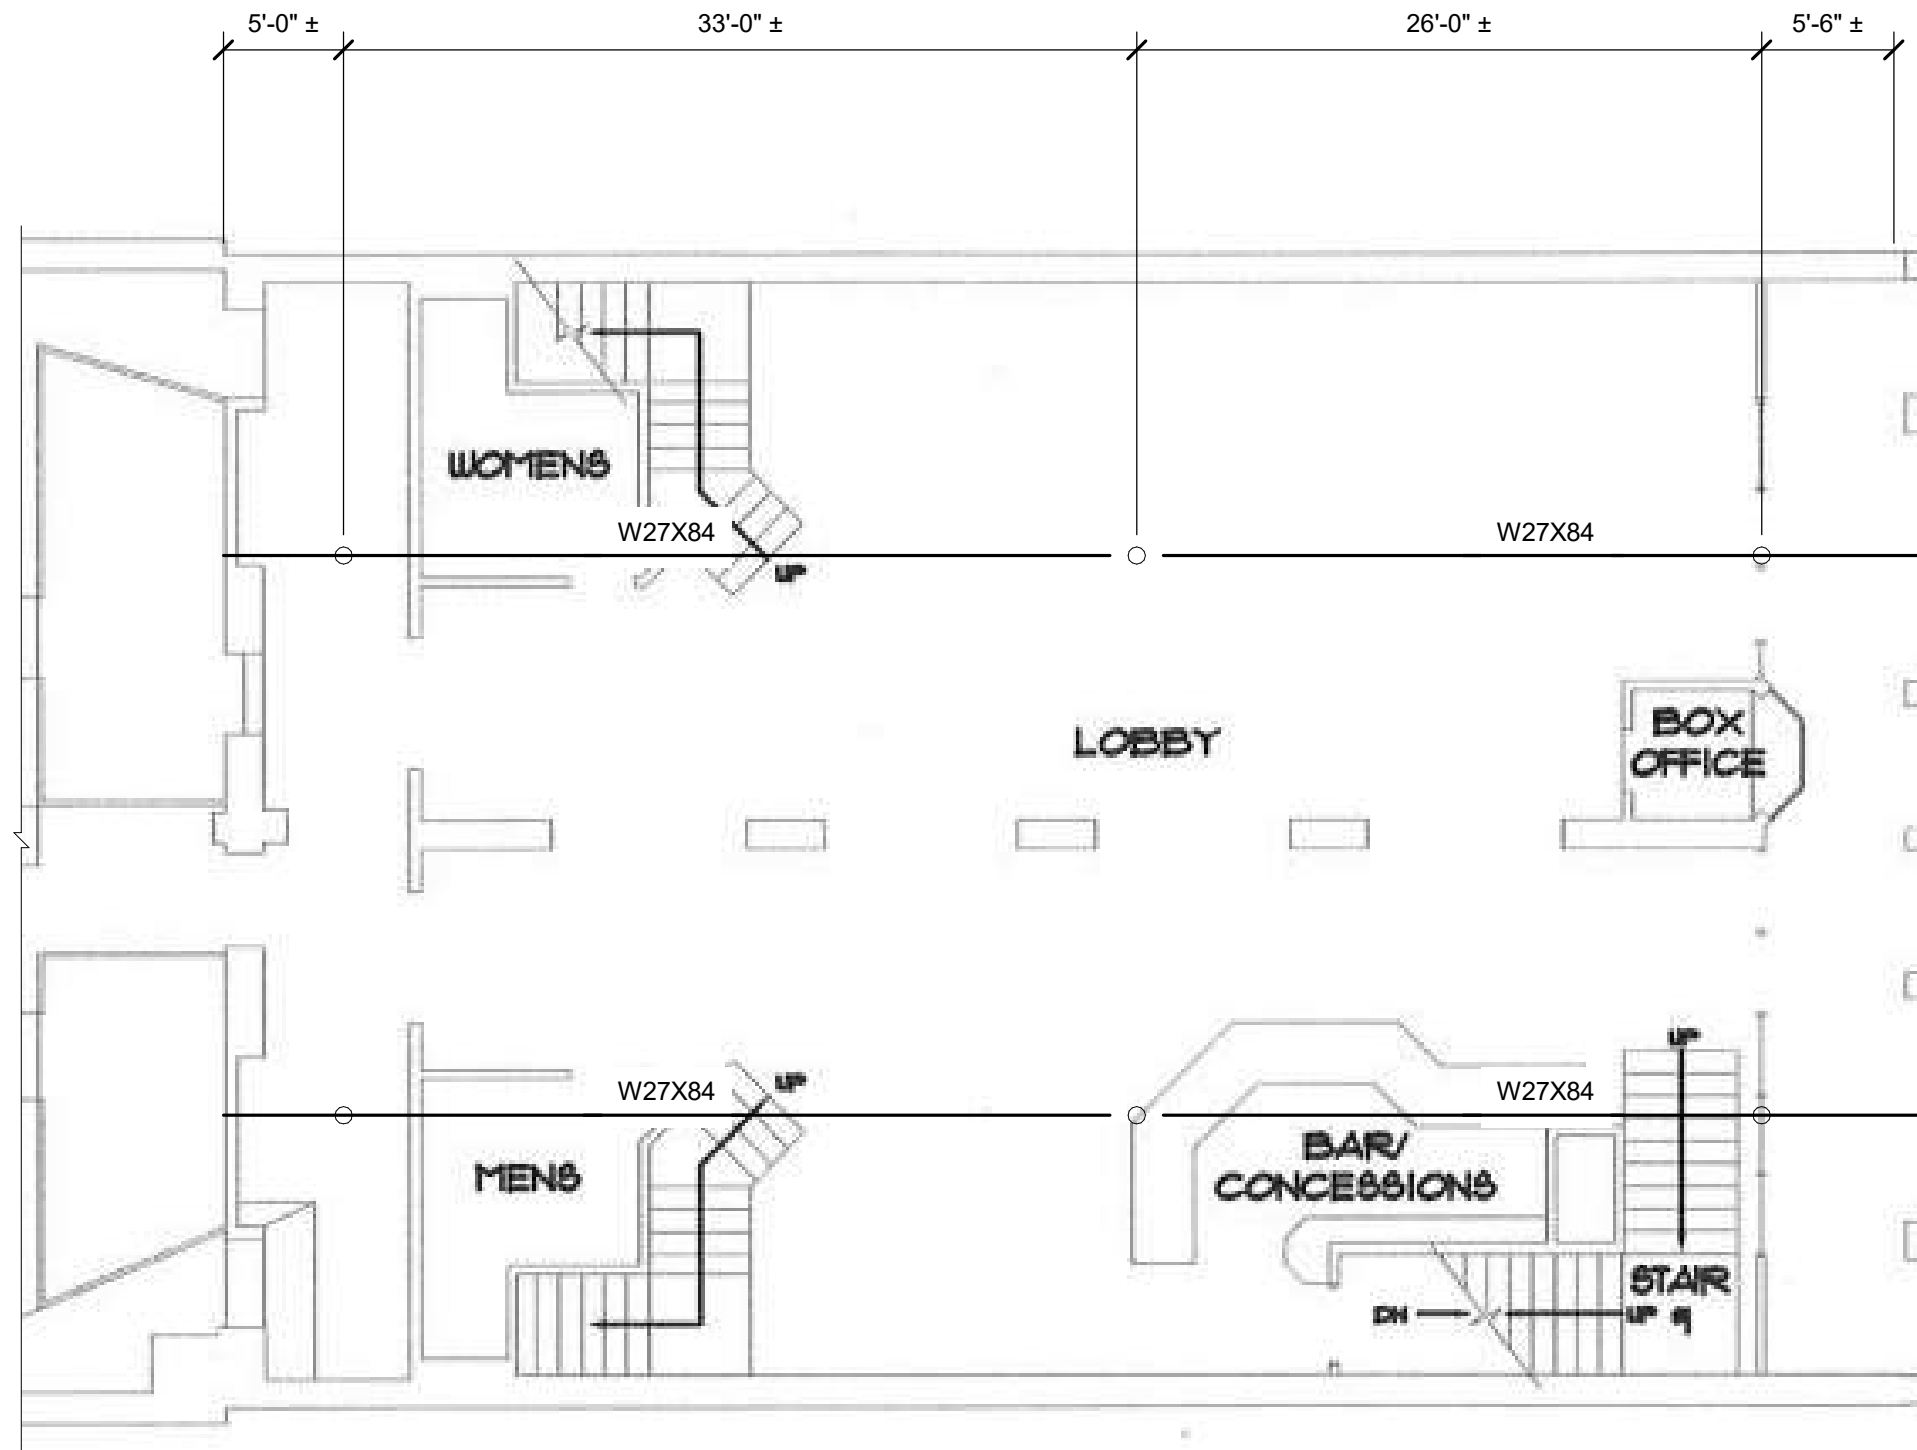
**SK-2**

# 1 STEEL FRAMING FOR SECOND FLOOR SUPPORT NO SCALE

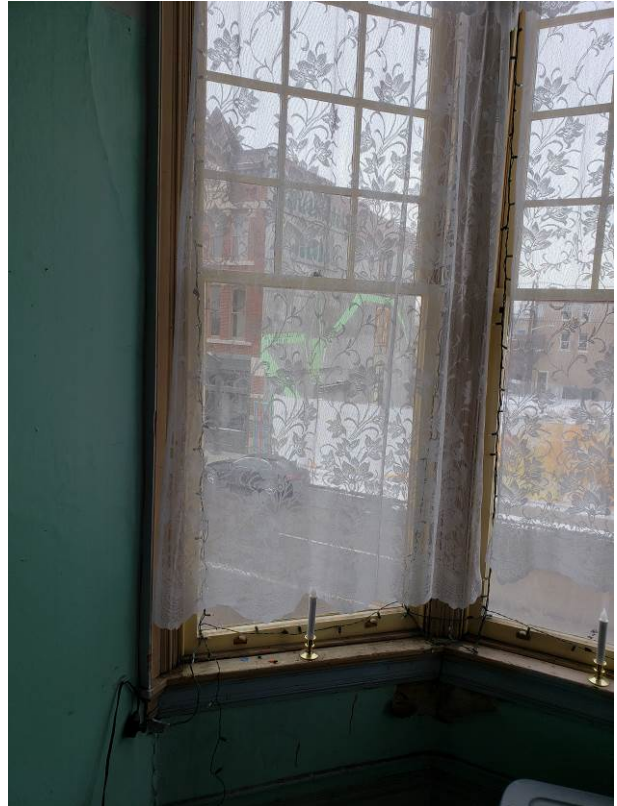
**Water damage to plaster detail**

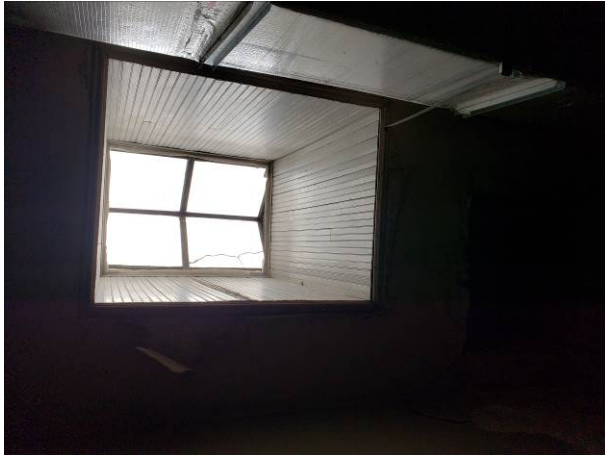
Skylight at top of stair landing

Skylight repair/reinstallation (both buildings)
