# Dry Creek Drainage Master Plan Update

August 2023

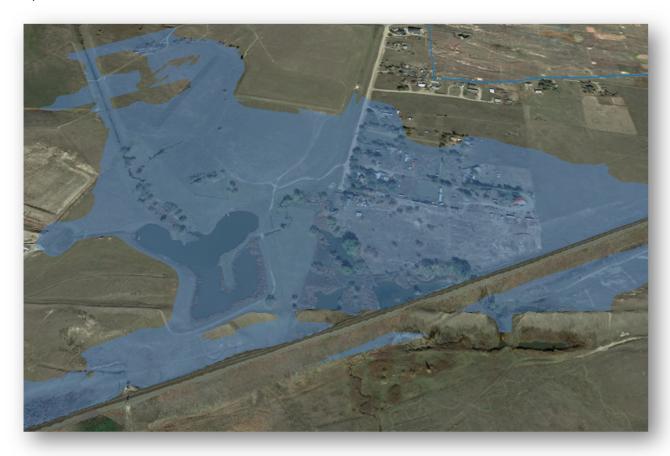
Figure 2. Detention Storage at UPRR Crossing for 100-Year Event

Since 1950, much of the Dry Creek Basin has been platted and subdivided with correspondingly significant changes to the historic meandering pattern of Dry Creek. Since the turn of the last century when the Union Pacific Railroad (UPRR) was reconstructed on the east side of the city, the upstream basin has dramatically changed from a predominantly rural basin to a nearly entirely urbanized one. The existing UPRR mainline tracks were constructed shortly after 1901 with the construction of a 6' x 8' masonry box arch culvert being completed in 1903. Currently the project area serves as an unintentional detention storage area for stormwater runoff in Lower Dry Creek and has been modeled as such since at least the 1970's. Significant impoundment of floodwaters against the Union Pacific embankment has been noted by the U.S. Geological Survey (USGS) and others for flood events having occurred in the 1920's, 1950's, 1970's and for the record-setting 1985 flood event. The project area is modeled as a sump in the 1988 Dry Creek Master Drainage Plan USACE HEC-1 hydrologic model. The UP sump is a significant constriction for the upstream basin and the resulting inundated area is shown below in **Figure 2** for a 100-year flood event.

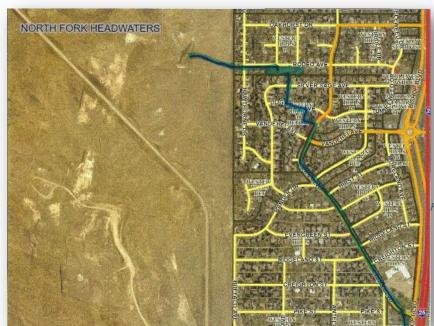
Figure 11. North Fork of Dry Creek in Western Hills

The Dry Creek Basin is generally formed by bluffs and rolling hills with its headwaters located on Francis E. Warren Air Force Base (FEW) property where runoff enters the city in either the North Fork or South Fork of Dry Creek within the Western Hills subdivision. Refer to **Figures 11 and 12**. At the time of the March 2000 Surface Water Drainage Committee Final Report, the consensus of committee members from the city, County, WyDOT, and F.E. Warren AFB was to divert floodwaters from the north headwaters' detention pond to the south fork headwaters. This remains a recommendation of this study update as it would reduce the cost for improvements to the emergency spillway for the north fork detention pond.

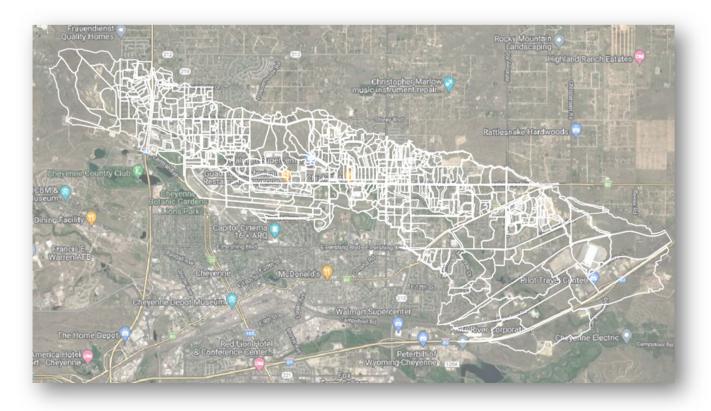
Figure 14. EPA SWMM Model Subbasins

The SWMM model developed in support of this master plan update covers the entire 16 square mile drainage basin. Unlike the original HEC-1 model or recent staff EPA SWMM model, this model is a very detailed model with over a thousand subbasins, giving it a much higher resolution than the earlier models. Figure 11 shows the delineation of subbasins comprising the SWMM model for this master plan update. The SWMM model was set up by inputting basin data into the software. Defining the study area boundaries, specifying sub-areas, establishing drainage network elements (e.g., pipes, channels, junctions), and assigning properties to these elements (e.g., dimensions, roughness coefficients). Initial values for SWMM parameters were assigned based on engineering judgment, prior knowledge of the study area, and typical values from similar projects or published literature. These initial estimates provided a starting point for the subsequent calibration process with previous basin models and with staff guidance.

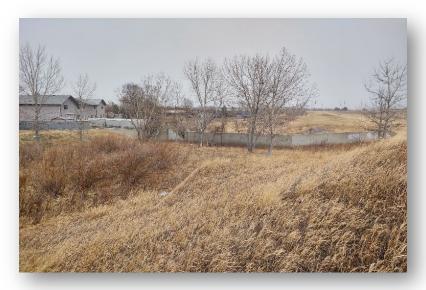
Figure 15. Carey Reservoir Inlet Structure

The Carey Reservoir inlet is proposed to be reconstructed to realign the main channel flow through this reach and away from the Sheridan Street reach. Included in this improvement is a lowering of the grade between Powderhouse and Carey Reservoir to provide additional creek capacity and eliminate a "bottle neck" in the reach immediately upstream of the Carey Reservoir inlet. The existing Bureau of Reclamation energy dissipation design would be modified to accept emergency spills at a higher water surface elevation.

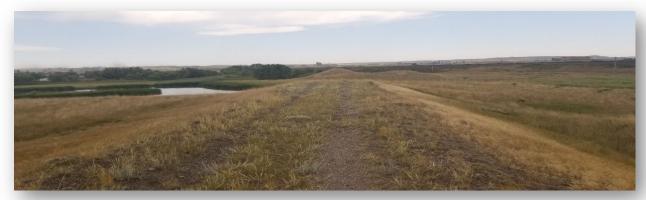
Figure 16. Transcontinental Rail Berm

The Union Pacific floodwater impoundment area is proposed to be reconfigured such that floodwaters are kept away from the UPRR embankment and the existing 6' x 8' masonry box arch culvert is hydraulically isolated for use as a pedestrian connection for the Greater Cheyenne Greenway system. A repurposing of the historic transcontinental rail berm is proposed to keep floodwaters away from the UPRR embankment located immediately downstream.

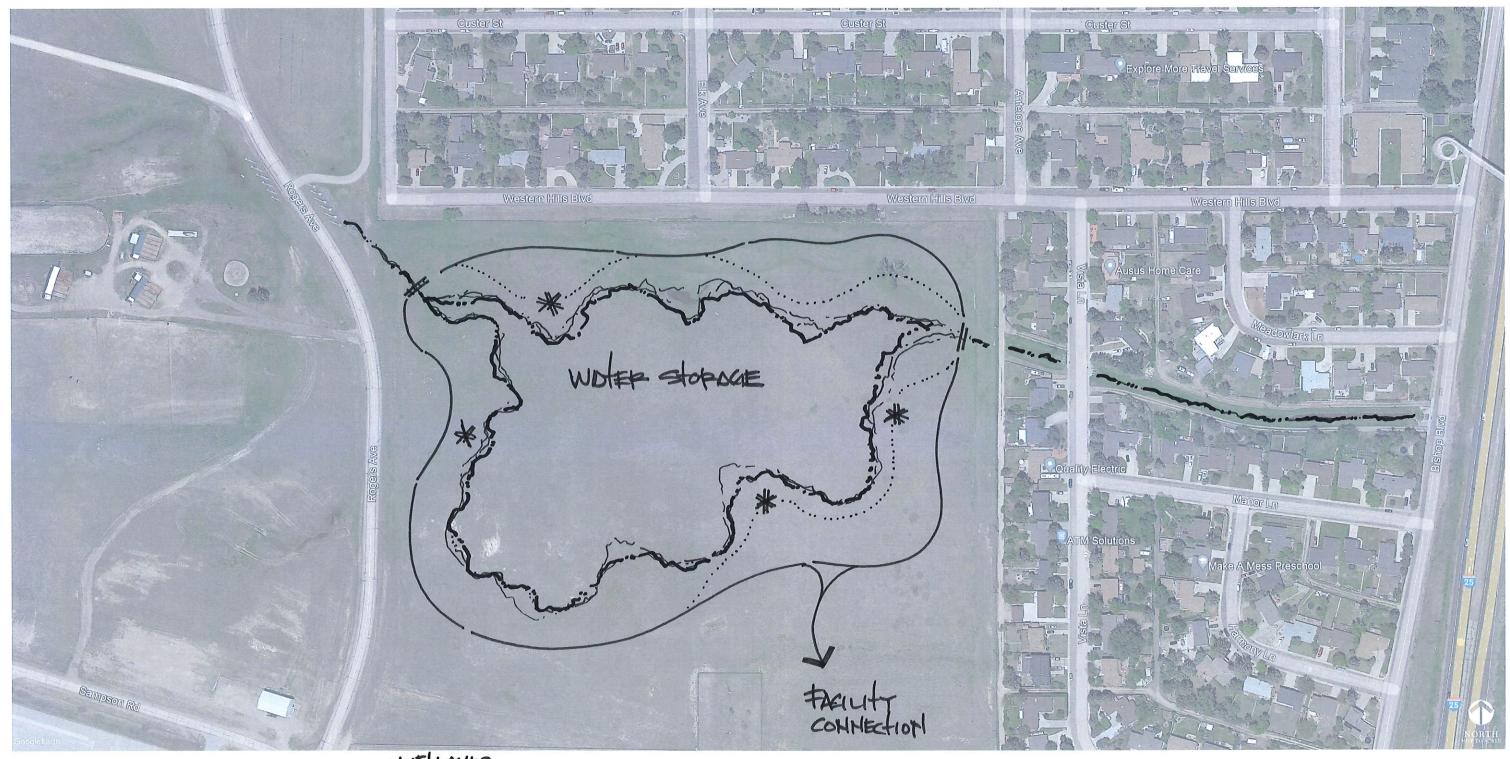
## PROJECT AREA I WARREN AIR FORCE BASE

- · WETLANDS · OPEN SPACE · LOOPED TRAILS · SHADE STRUCTURES · PED CONHECTIONS

The initial conceptual projects focused on detention storage, creek restoration, and enhancement of greenway and park amenities along the creek and are presented in **Figures 53 through 70**. These conceptual alternatives were presented to staff and the project stakeholders for review and comments. Detention storage was proposed for the Headwaters to Yellowstone Rd. reach and for the Yellowstone to Powderhouse Rd. reach. Reconfiguration of the UPRR sump 130 was also brought forward for consideration by staff and the stakeholder's group. Creek restoration projects were conceptually proposed for the McCormick — Central campus, downstream Yellowstone reach, Smalley Park, Powderhouse reach, the Sheridan Flood Control alignment, the Sheridan Street reach and at the confluence. Trail and park amenities were proposed for the Powderhouse reach, along the Sheridan Flood Control alignment, and downstream of Ridge Rd. Amphitheaters were proposed for the Cahill Park area and the LCCD managed area south of the UPRR (The LCCD amphitheater had been master planned several years prior to this study update). Parks & Rec Frisbee golf course improvements at Mylar Park and upstream of U.S. 30 were also proposed and vetted by Mr. Jason Sanchez, Cheyenne Parks Department Director.

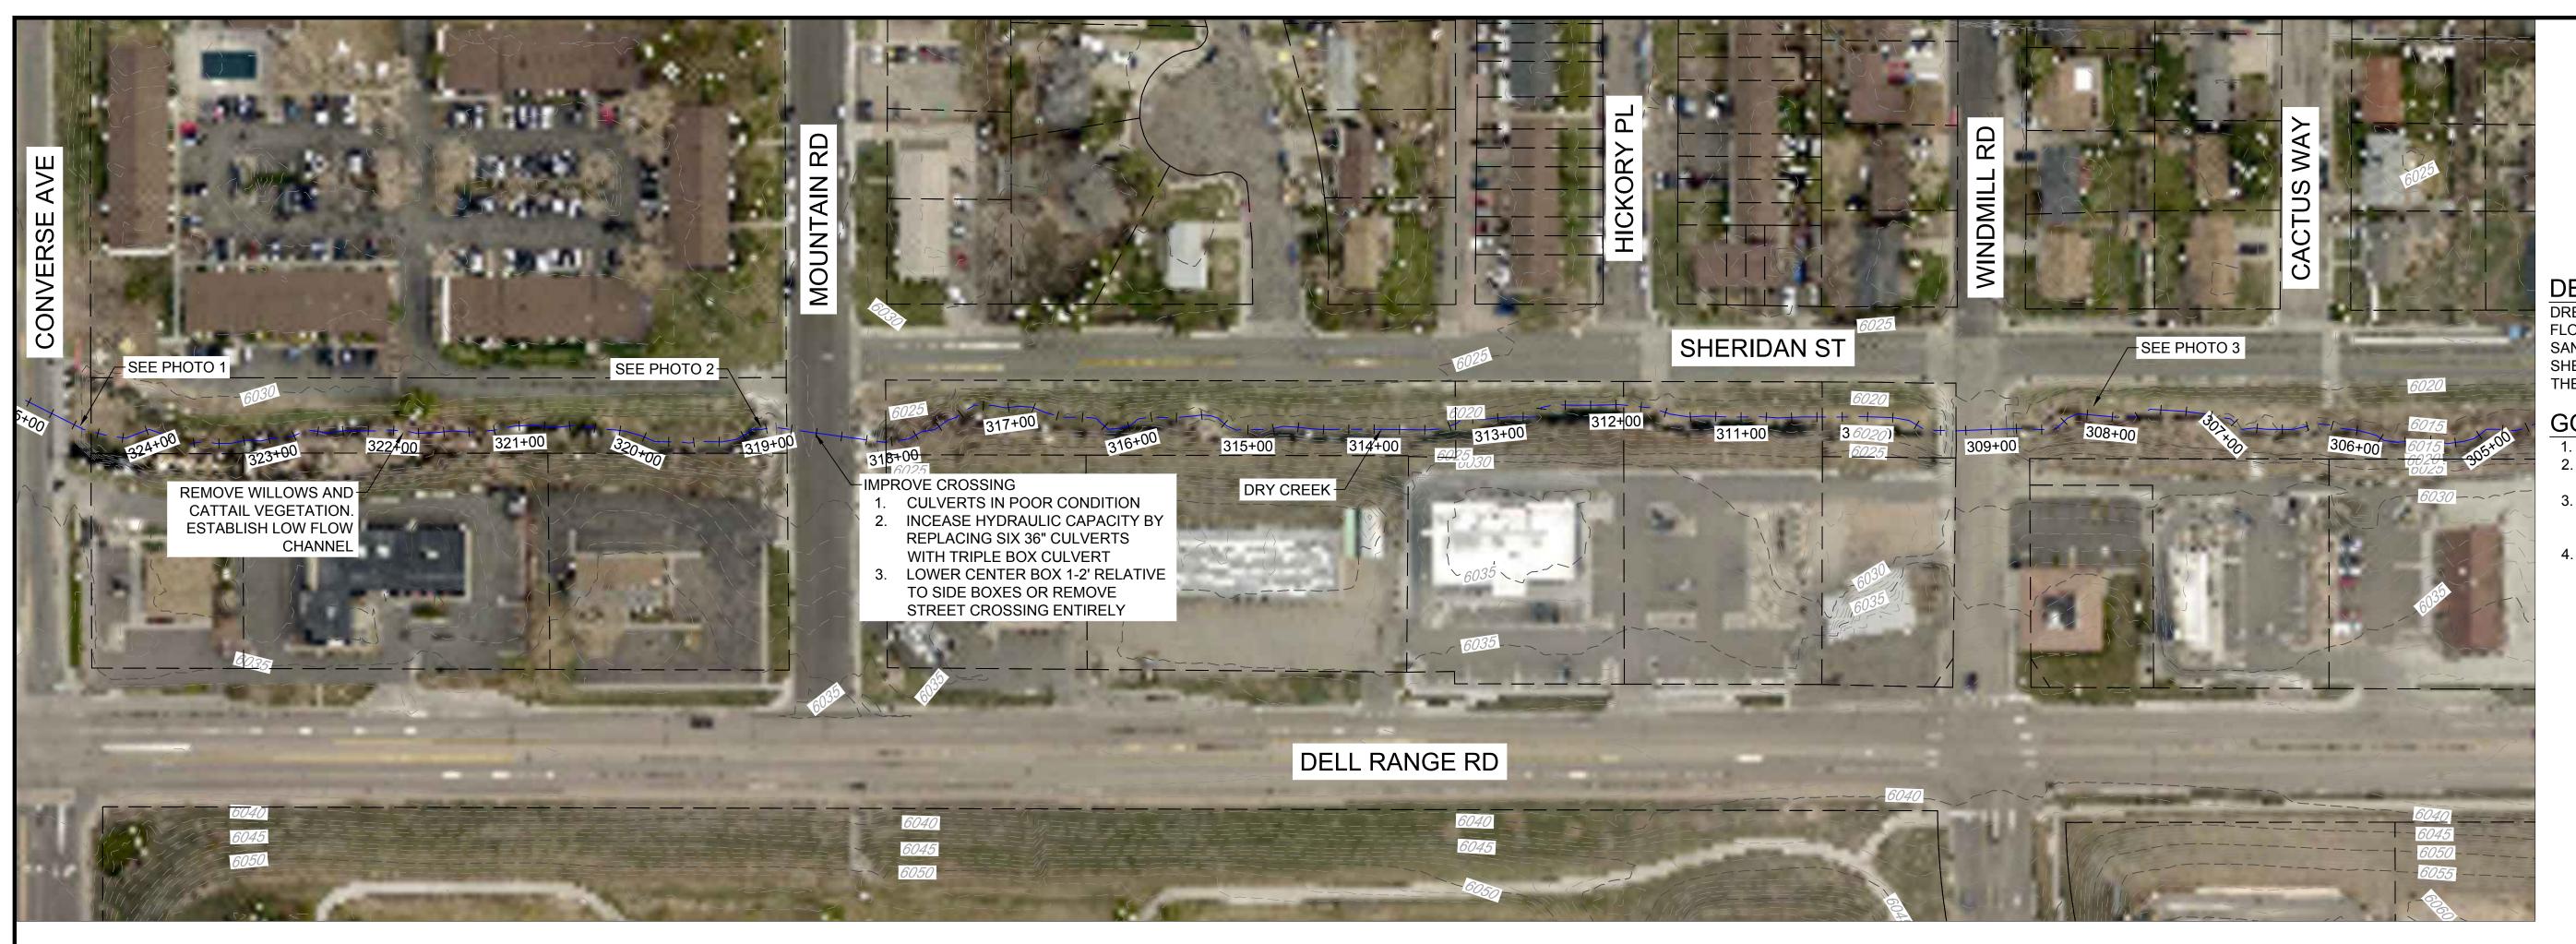
DRY CREEK CHEYENNE	
	CONCEPTUAL DESIGN	
23-011	REACH G CONCEPT - 5

# DESCRIPTION:

DREDGE CHANNEL TO EXPAND FLOODPLAIN CAPACITY. RELOCATE SANITARY SEWER LINE UNDER SHERIDAN. MAKE IMPROVEMENTS TO THE MOUNTAIN ROAD CROSSING.

- 1. REDUCE SEDIMENTATION
- 2. ESTABLISH LOW FLOW CHANNEL
- 3. IMPROVE HYDRAULIC CAPACITY AND FUNCTIONALITY OF CROSSINGS
- 4. INCREASE SANITARY SEWER MAINTENANCE ACCESS

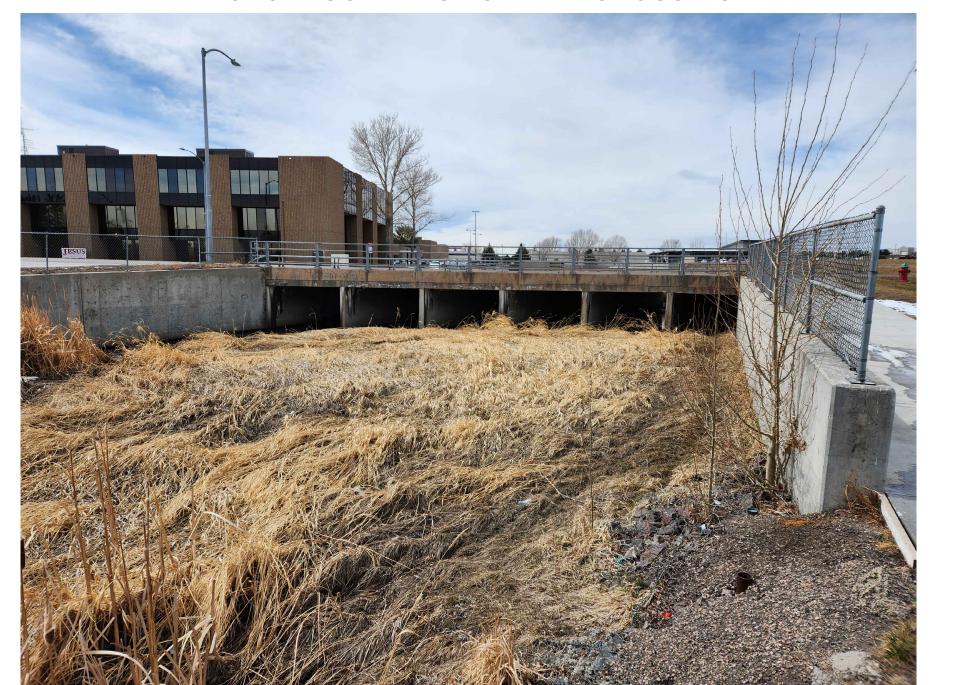
# PHOTO 1: CONVERSE STREET CROSSING

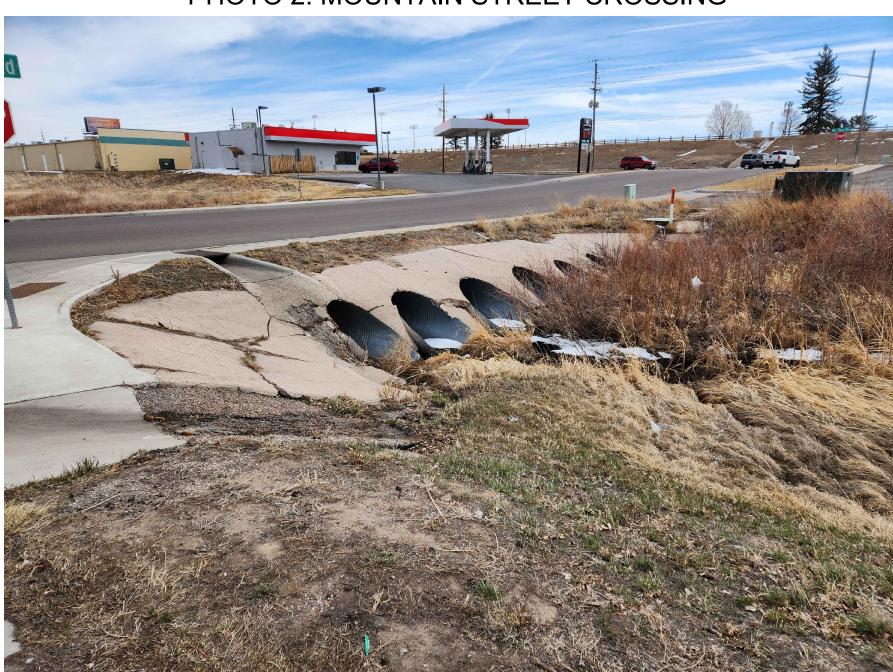
# PHOTO 2: MOUNTAIN STREET CROSSING

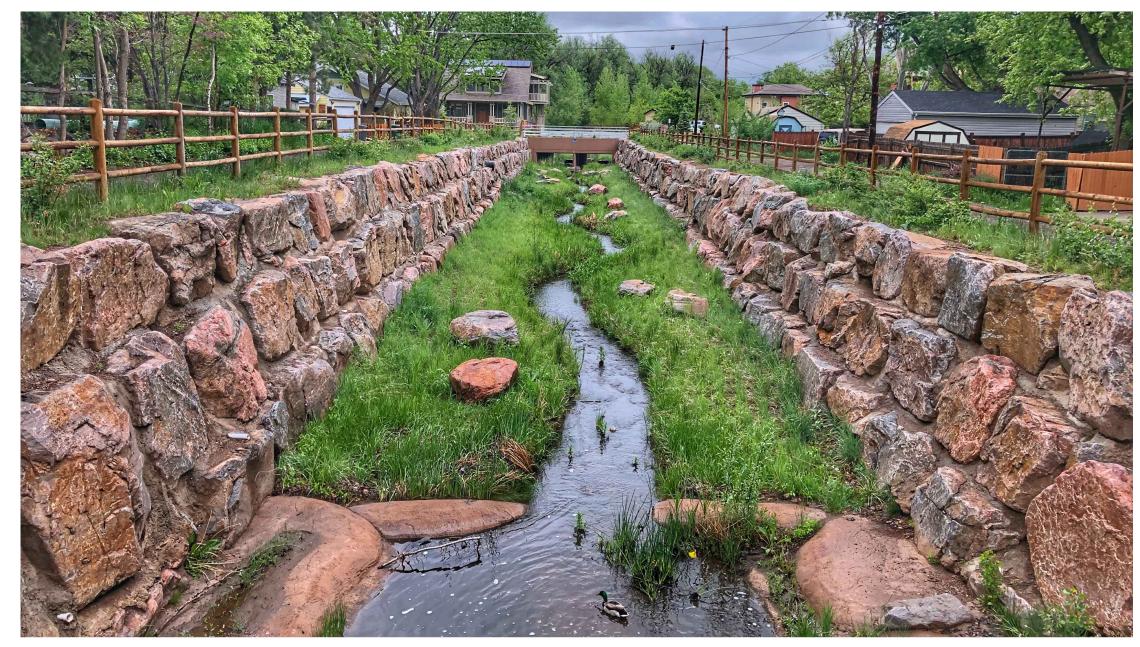
## PHOTO 6: CONFINED URBAN STREAM WITH DEFINED LOW FLOW CHANNEL

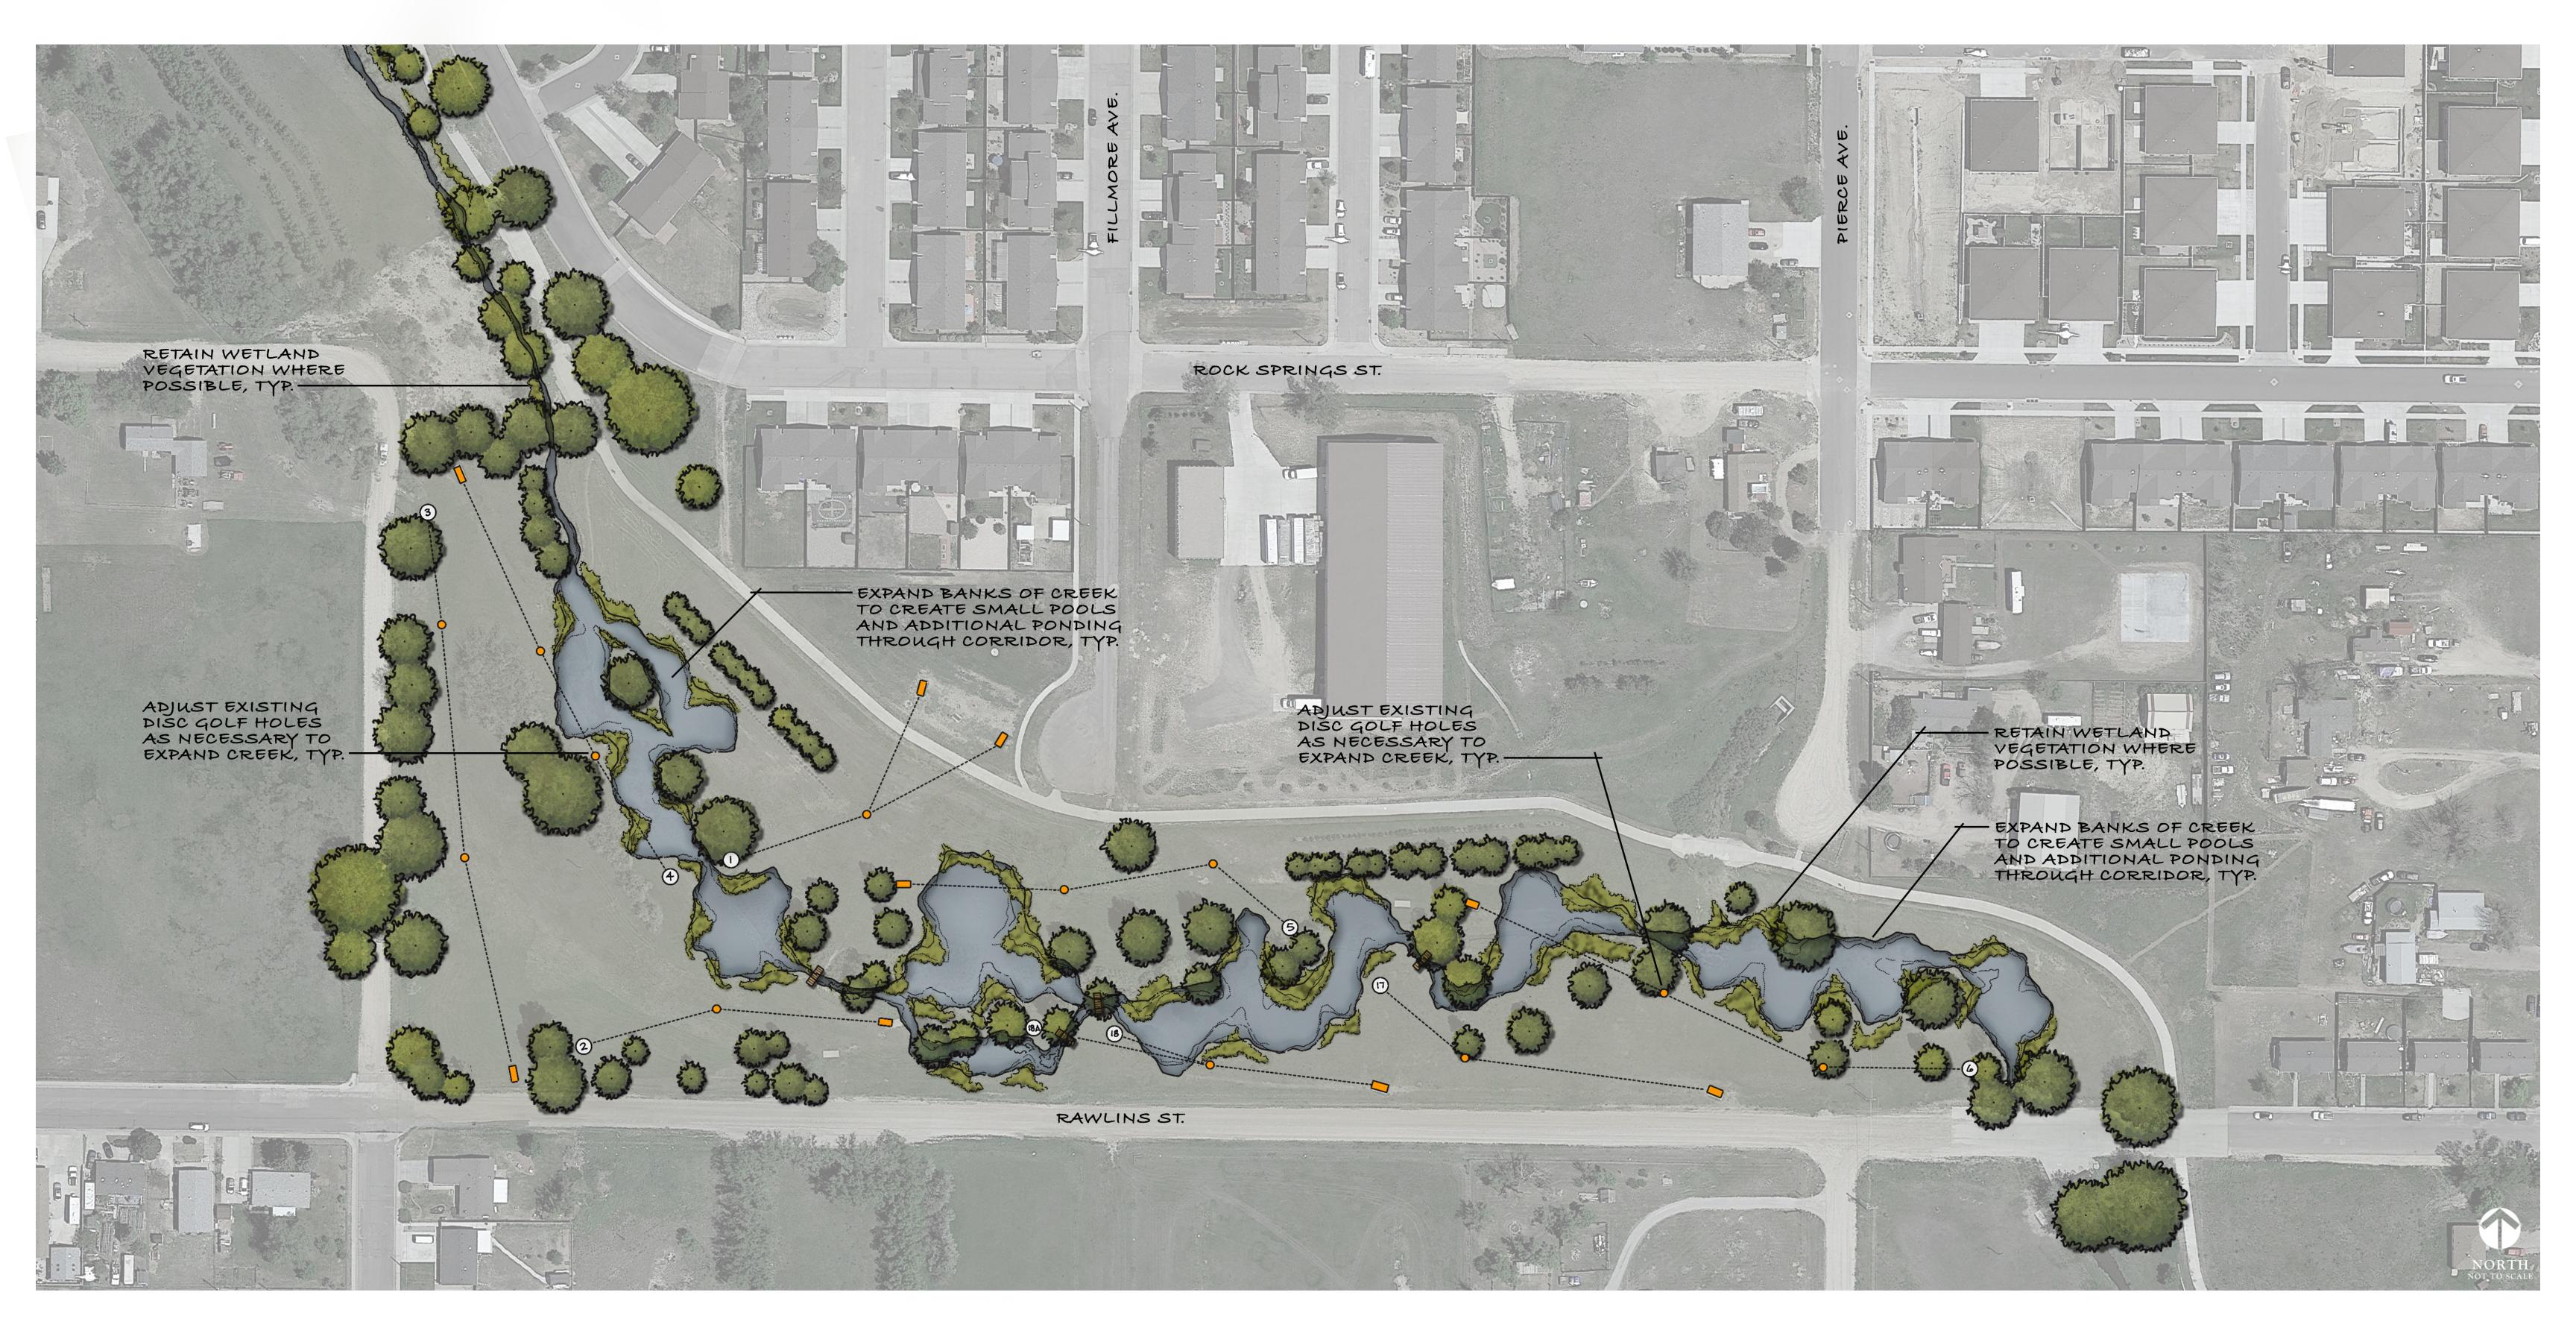
SHEET 1 OF 2

# PROJECT AREA I DRY CREEK DISC GOLF COURSE

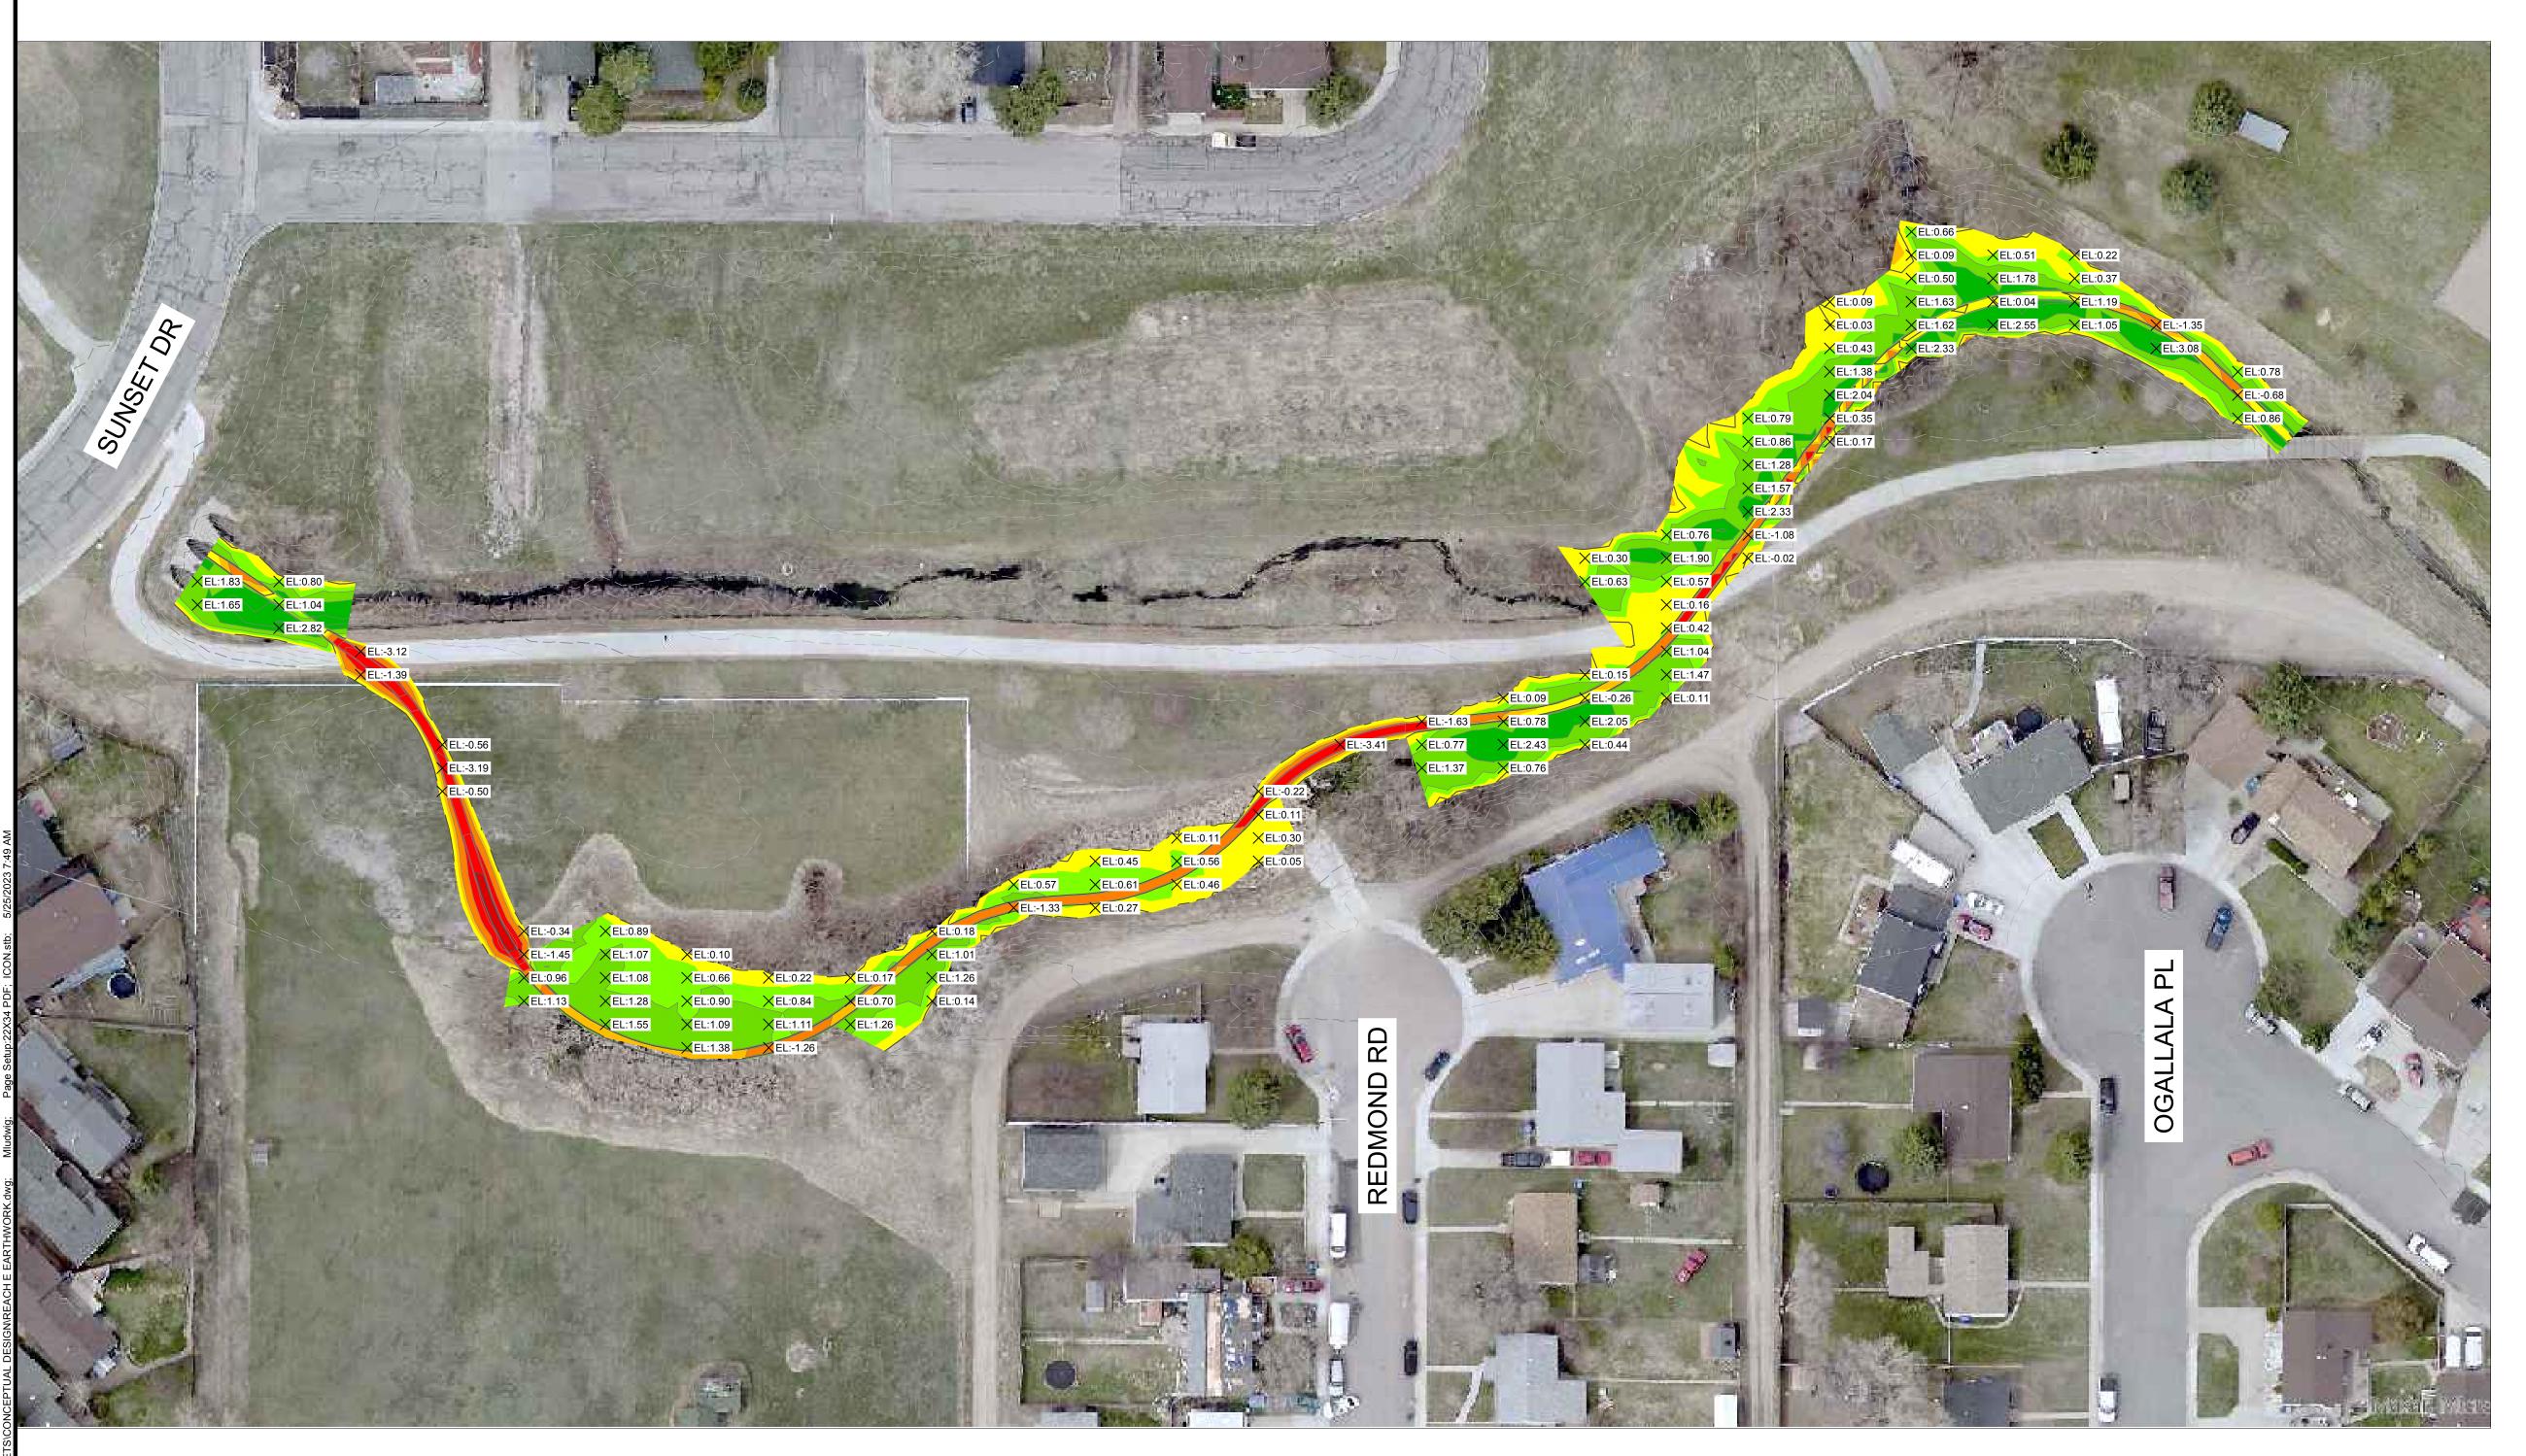
DRY CREEK CHEYENNE	
CONCEPTUAL DESIGN	
REACH E EARTHWORK

EARTHWORK:

- <u>NOTES:</u>
  1. EARTHWORK QUANTITIES WERE CALCULATED AS THE DIFFERENCE BETWEEN THE EXISTING AND PROPOSED SURFACES AND DO NOT INCLUDE SOIL VOLUME ADJUSTMENTS RELATED TO RIPRAP OR CONCRETE INSTALLATION
- 2. MINIMIZE SURFACE AREA OF FILL AREA PER REACH OF THE PROJECT TO MINIMIZE REVEGETATION NEEDS.
- 3. CONTRACTOR SHALL STRIP AND REPLACE TOPSOIL AT THIS LOCATION TO A DEPTH OF 6 **INCHES**

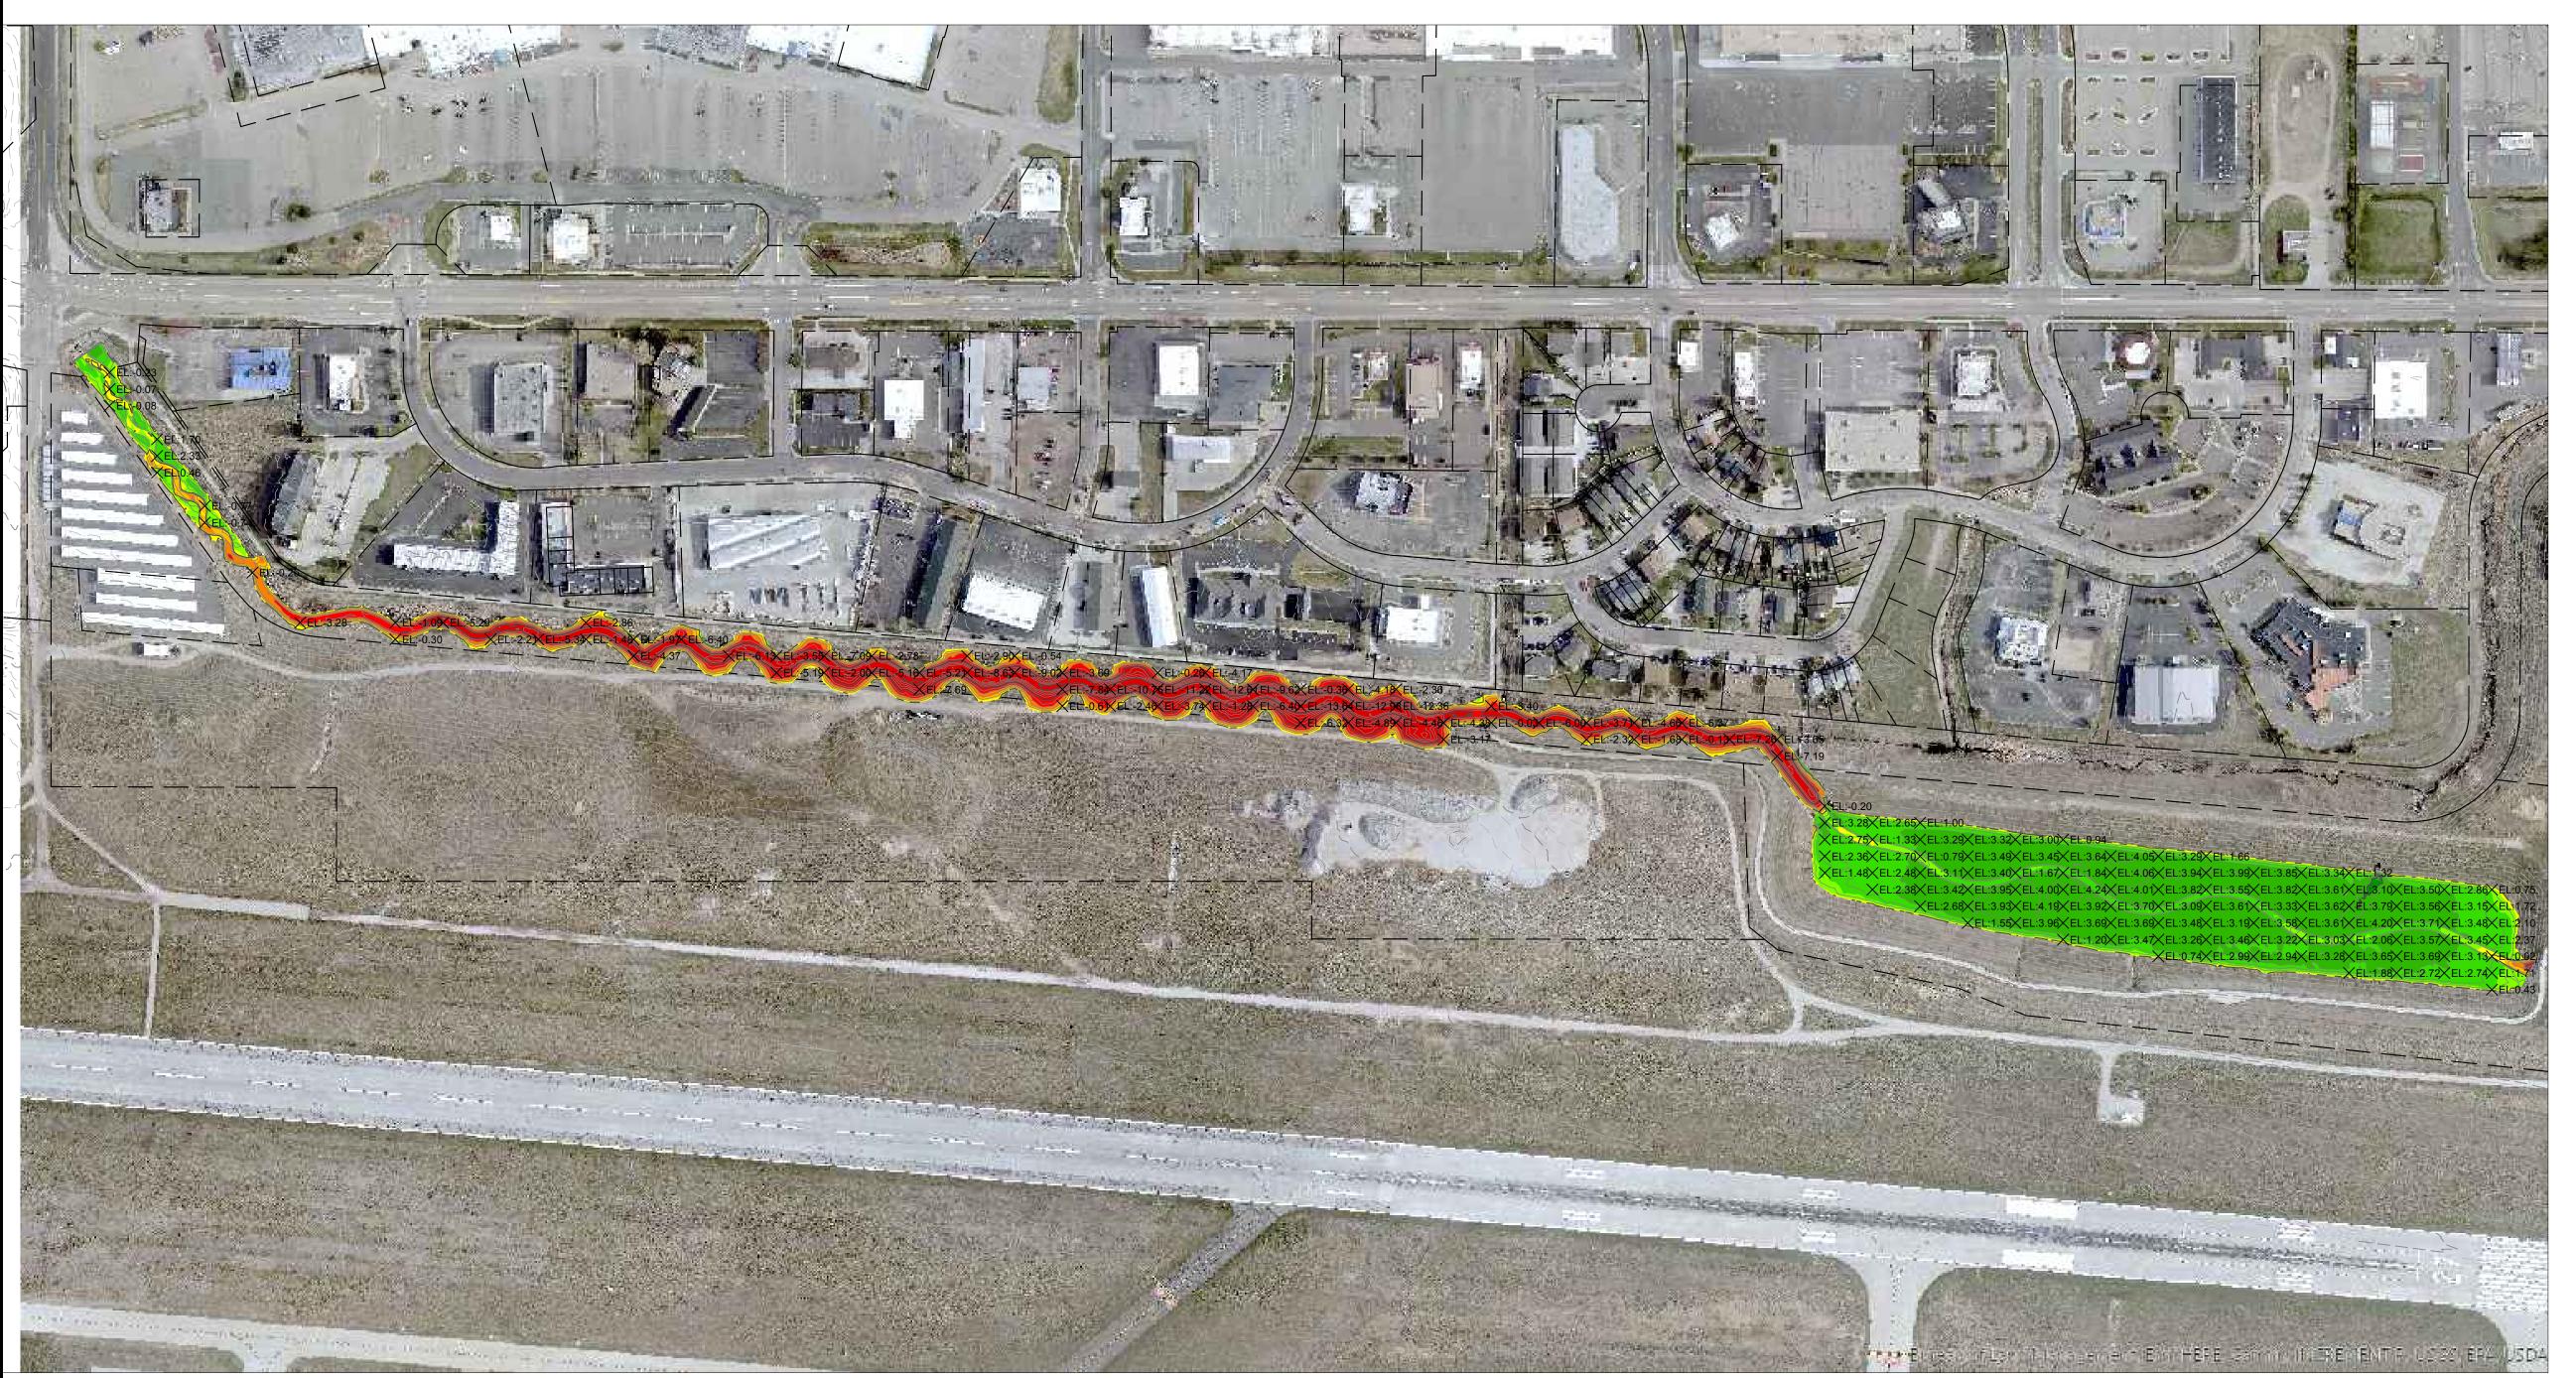
DRY CREEK CHEYENNE	DATE
CONCEPTUAL DESIGN	JUNE 2023
CONCLITOAL DESIGN	SHEET
REACH G EARTHWORK	20 OF 21

**EARTHWORK**:

- EARTHWORK QUANTITIES WERE CALCULATED AS PROPOSED SURFACES AND DO NOT INCLUDE SOIL VOLUME ADJUSTMENTS RELATED TO RIPRAP OR CONCRETE INSTALLATION
- 2. MINIMIZE SURFACE AREA OF FILL AREA PER REACH OF THE PROJECT TO MINIMIZE REVEGETATION NEEDS.
- 3. CONTRACTOR SHALL STRIP AND REPLACE TOPSOIL AT THIS LOCATION TO A DEPTH OF 6 **INCHES**
